Discontinuity Controlled Cut-Slope Failures on Weathered Low Grade Metamorphic Rocks along the East-West Highway, Grik to Jeli

Mustaffa Kamal Shuib¹, Samsudin Hj Taib¹ And Mazlan Abdullah²

Abstract: This paper describes the occurrence and mechanism of discontinuity-controlled cut-slope failures within the residual soil zone and the underlying weathered metasedimentary and metamorphic rocks, drawing on the experience gained from investigations of a number of landslides observed on the cut-slopes of the East-West Highway. These slope failures highlighted the important influence that discontinuities in residual soils and weathered rocks can have on slope stability. The slope movements recognised in the metasedimentary and metamorphic rock slopes along the East-West Highway are: - A) movements of rock-soil cover through: (i) movement of loose soil and weathered fragments, and ii) rotational sliding movements or slumps, B) movements of loosened blocks (rockfalls), C) movement of intact rocks along predetermined planes (slides), D) progressive complex movements. Slope failures are found to be largely controlled by the unfavourable orientation of discontinuities with respect to the slop

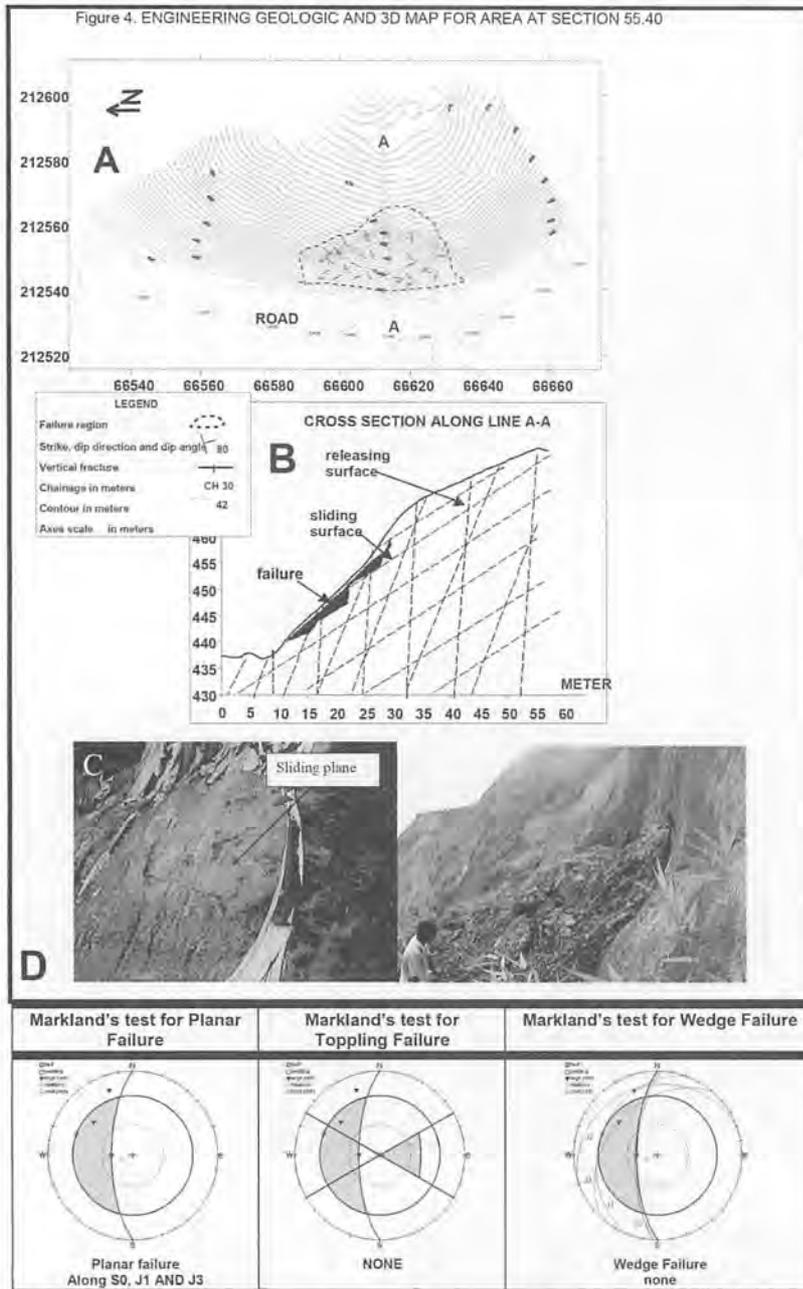
Figure 4. Characteristics of slope failures at km 55.

- A) geologic map showing the Movement of loose soil and weathered fragments
- B) cross section showing Movement of loose soil and weathered fragments
- C) photographs showing the Movement of loose soil and weathered fragments along the slope parallel sliding planes.
- D) slope stability kinematic analysis results.

Residual soil and fragments of weathered phyllite and quartzite move down slope gradually and accumulate as talus at the slope toe (Figure 4). The displaced debris represents loose soil and fragments, which have weathered from the surface layers of the parent material and have remained unstably positioned on the slope. Observation of these landslides has indicated that the downward movement occurs either along one plane of weakness that are either joint or bedding planes. The volume of material, which moves at any time, is generally small (a few cubic metres). However, other such unstable material can move down slope subsequently and add to the volume of the fallen mass. Typical examples of this type of movement are described as case 1.

(Figure 4 A). It occurred on the top to the bottommost bench of the road cut. The slope is underlain by schistose sequence belonging to the Lower Palaeozoic unit. The rocks are well foliated with foliation parallel quartz veins. The beds are deeply weathered to clayey soil. The rock weathered to brownish red silty CLAY. They are highly fractured. Bedding/foliation is steeply dipping along the slope and can be distinguished from relict joints and fractures. The failure occurs as surface movement of soil and weathered materials. Failure occurs by sliding along the rock-soil contact, which is defined by bedding, and foliation planes (Figure 4 B, C and D).

Results of kinematics stability analyses (Figure 4 D) indicated that the moderately to steep westerly dipping foliation planes and NW dipping bedding planes are identified as the critical planes of weakness in the slope. These discontinuities meet the condition where planar failure is kinematically possible.

The residual soil and weathered material already had some potential for swelling and surface creep. However, the creep movements observed at this site is considered to be initially controlled by the bedding planes and relict joints parallel to the slope face in the weathered material. They would have started opening up due to stress release subsequent to excavation. This mechanism, coupled with the swelling of clay minerals, would have resulted in the more rapid disturbance of the upper portion of the soil mass. Once disturbed, the mass would then have continued to deform at a slower rate with further weathering resulting in reduced shear resistance of the soil mass.

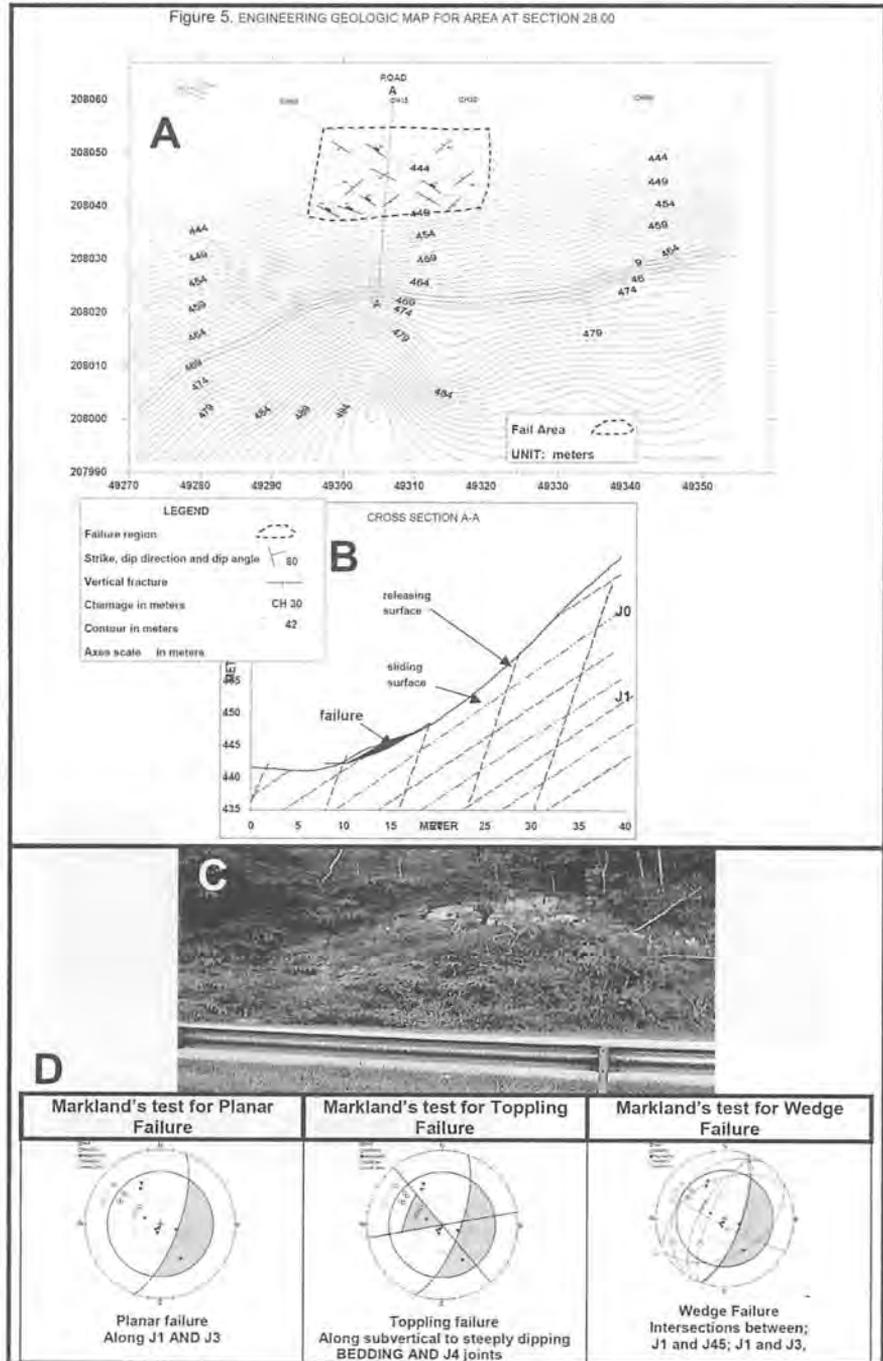
Figure 5. Characteristics of slope failures at km 28.00

- geologic map showing the circular failure in soil slope.
- cross section showing Movement of loose soil and weathered fragments
- photograph showing the circular failure controlled by joints
- results of slope stability kinematics analysis.

The landslide (Figure 5 A and C) is located along an eastward facing (020°/70° E) road cutting that trends northerly and sloping 70° E. The failure took place in well-foliated slates with well-developed slaty cleavage (foliation surfaces), grading from completely to slightly

weathered rock, with the depth of weathering being much greater in the upper portion of the slope. The rocks have been deeply weathered to clayey residual soil. The rock weathered to orangey red silty CLAY. At the bottom of the bench fresh slates rocks are exposed. They are highly fractured. At least 4 sets of major fractures are recognized (Figure 5 B).

The moderate to steeply southeast-dipping bedding and east dipping fracture surfaces were utilized as the planes of sliding during the failure event (Figure 5 B and C). Failure also occurred along a well-developed set of southeast dipping fracture surfaces. The east and southeast-dipping fractures and bedding acted as sliding surfaces, while the sliding rock mass is allowed to separate from the slope along a third set of more steeply inclined northerly dipping fracture planes that bounded the slides which are used as releasing surfaces. Another releasing surface that facilitate the sliding is the westerly slope inward dipping joints

- The slope failed by circular failure aided by discontinuities,
- Planar sliding planes along moderately south-easterly dipping joint planes
- Wedge failure along northerly and south-easterly joints

The presence of relict foliations and clay-filled joints at shallow depth within the weathered rock mass was a major contributory factor. Seepage reduces the stability of a slope by making it easier for the soil particles to slide over each other during failure. Similarly, pore water pressures associated the water saturated soil reduce the inherent strength and stability of the soil mass.

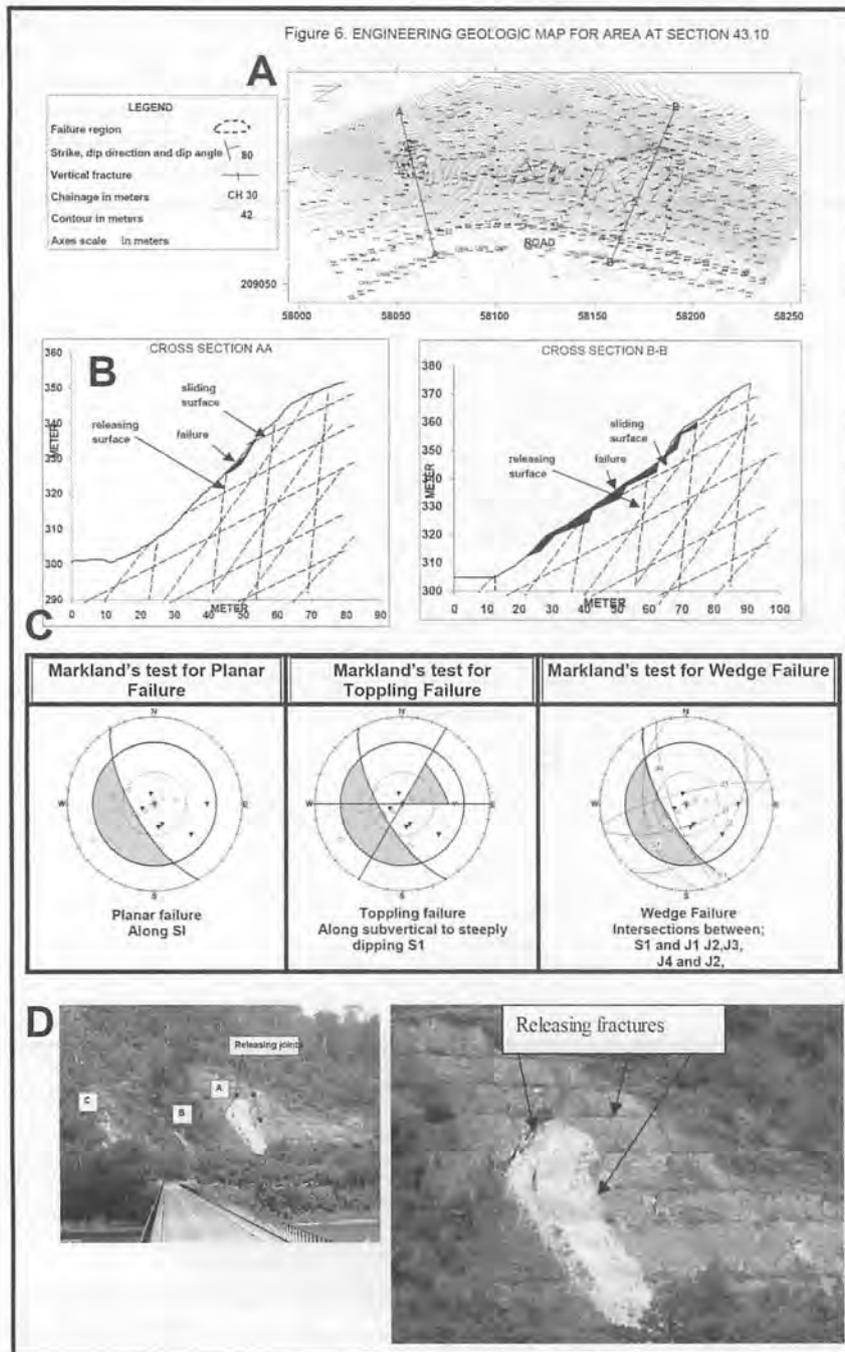
Figure 6. Characteristics of slope failures at km 43.1

- A) geologic map showing the discontinuity controlled slope failure geometry.
- B) cross section showing the sliding planes
- C) slope stability kinematic analysis results.
- D) photographs showing the releasing fractures and sliding planes.

The cut-slope on Pulau Banding (Figure 6 A and D) is underlain by quartzite and phyllites/slates interbedding sequence belonging to the Lower Paleozoic unit. The rocks are well-foliated. The beds are deeply weathered to clayey soil. The rock weathered to orangey brown silty CLAY. They are highly fractured. Bedding/foliation is steeply dipping along the slope and can be distinguished from clay-filled relict joints and fractures.

This is a very large slope that has three separate failures (Figure 6). The landslides are located along a westward facing road cutting at Pulau Banding that trend northerly and sloping 70° westward. The 3 landslides are very similar to each other and will be described together.

Releasing and sliding fracture surfaces (Figure 6 A and D) are exposed in the portion of the slope that formed the head scarp and the sliding planes. Surrounding all the three failures there are over steepened slopes that are critically unstable. The head scarp is over steepened at a slope of 90 degrees. Presently, the entire head scarp region is extremely unstable. The head scarp geometry is controlled by the major fractures presence. The head scarp is bounded by a releasing fracture as shown in Figure 6 D. These releasing fractures are clay-filled major joint surfaces that strike easterly, southeasterly and northerly with moderate to steep day lighting dip.

bedrock fractures (Figure 6 B and C). The foliation and bedding surfaces are sub-parallel to each other. They show contortions giving rise to warping of the strata. Although the strata are irregular, they generally dip southwesterly to westerly ranging from moderate to steep. Planar failure occurred along these strata. Where the strata dipped steeply inward of the slope (east dipping), failure in the upper slope region occurred by toppling. The moderate to steeply east-dipping bedding surfaces that dipped inward into the slope were utilized as the planes of toppling during the failure event.

Failure also occurred by sliding along wedges (Figure 6 C and D) that plunges southwesterly due to the intersection between fracture surfaces and bedding or between differently oriented joint surfaces followed by rapid tumbling of the failed mass down slope.

Based on stereographic projection shown in Figure 6 C, the discontinuities in slope 43.1 comprises beddings and at least of 4 sets of joints labelled J1 to J4: Based on the analysis as shown by the Markland's tests for failure: Failure occurred along south-westerly dipping foliations aided by variably oriented releasing joints that give rise to planar, wedge and toppling failures.

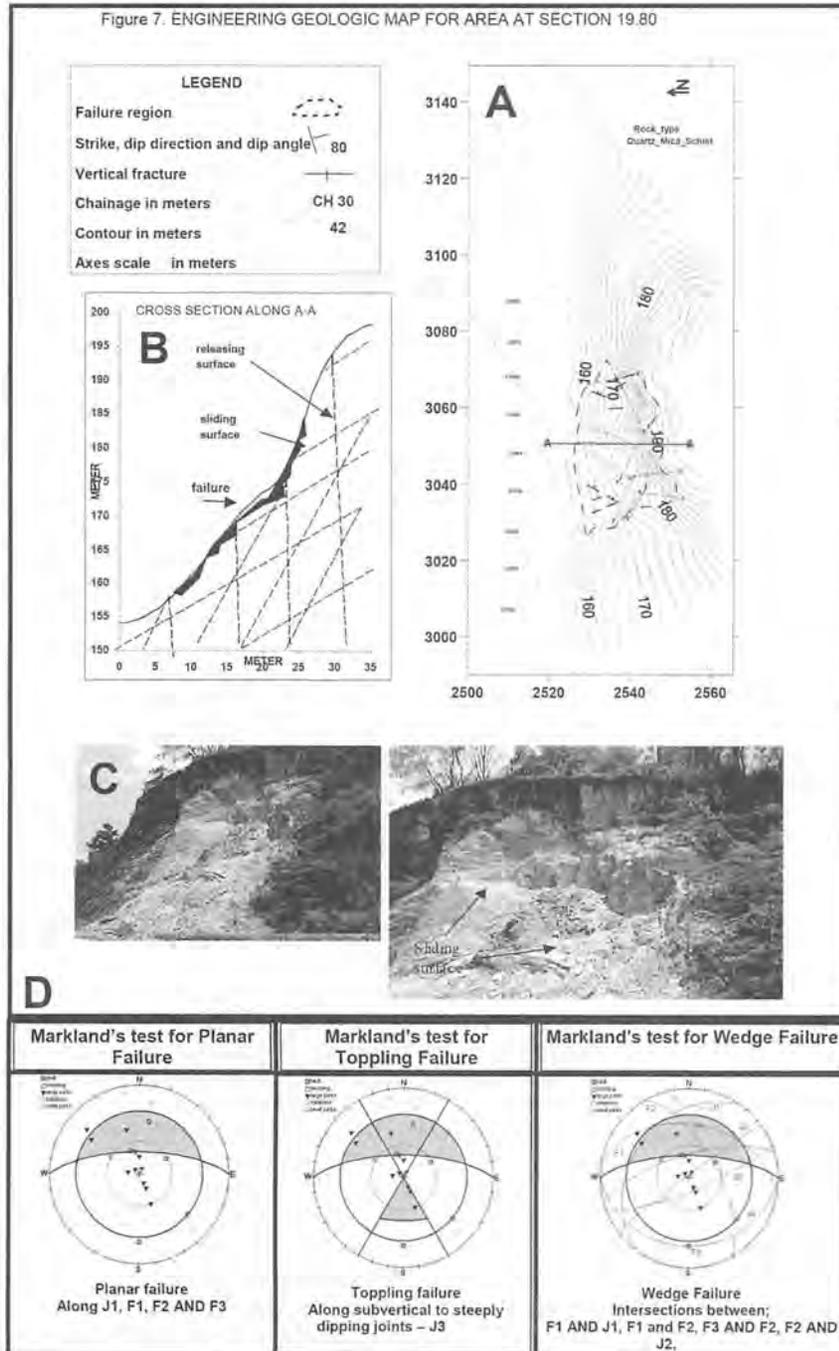
Figure 7. Characteristics of slope failures at km 19.8

- geologic map showing the discontinuity controlled slope failure geometry.
- cross section showing sliding planes
- photographs showing the discontinuity controlled slope failure
- slope stability kinematic analysis results.

Figure 7 A - D illustrates slope at section 19.8. The failure includes rockslides and rock flows. The moderate to steeply northwest-dipping and northeast-dipping fracture surfaces was utilized as the planes of sliding during the failure event. Failure also occurred along a well-developed set of northwest-dipping foliation surfaces.

Our investigation has confirmed that the northeast and northwest-dipping fractures which act as sliding surfaces, while the sliding rock mass is allowed to separate from the slope along a third set of more steeply inclined easterly dipping fracture planes which are used as releasing surfaces. Presently, the movement at the toe of the landslide has been stabilized by the presence of a

gabion wall. Surrounding the failure there are over steepened slopes that are critically unstable. The head scarp is over steepened at slope angles of up to locally 90 degrees. Presently, the entire head scarp region is extremely unstable. In the upper slope, sliding is controlled by the location and orientation of the bedrock fractures. Releasing and sliding fracture surfaces are exposed in the portion of the slope that formed the head scarp and the sliding planes.

Based on the analysis as shown by the Markland's tests for failure (Figure 7 D). The slope is susceptible to planar, toppling and wedge failures.

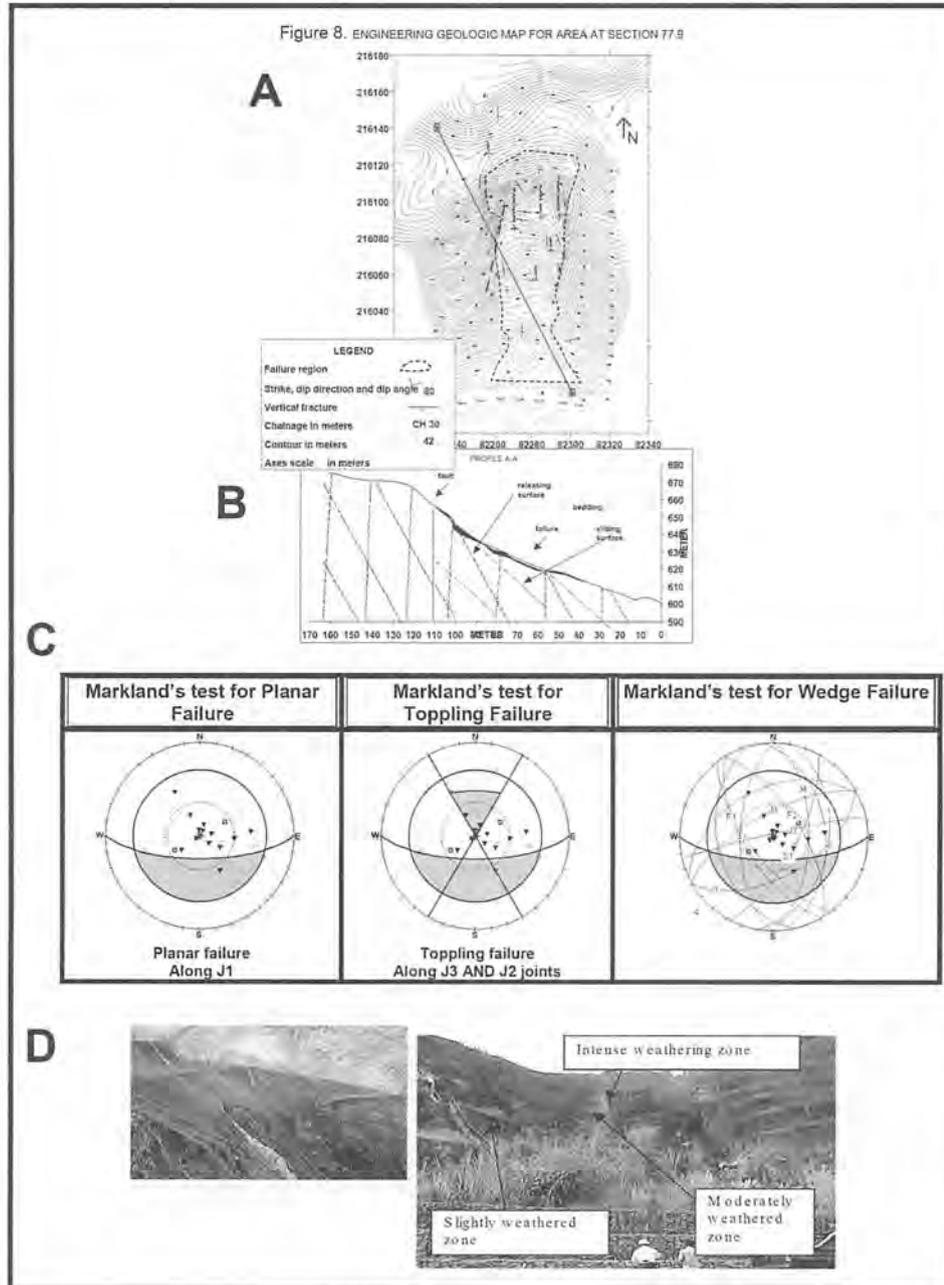
Figure 8. Characteristics of slope failures at km 77.9

This slope (Figure 8 A - D) has been remedied several times but failures keep on occurring especially after heavy rain. Complex slope failures involving relatively deep-seated shear planes or zones conditioned by complex weathering and alteration conditions, discontinuity patterns, have occurred in cut slopes at section 77.9. The failure of these slopes, which had relatively gentle profiles of less than 60°, took place progressively with significant movements occurring during or shortly after rainfall, but not always heavy rainfall.

The schist is well foliated and highly weathered. Weathering and erosion followed by continuous slope failures created a V-shaped valley. The axis of the valley is made up of a 2m wide zone of intensely weathered schist (Figure 8 D). Here the schist has been weathered to whitish clayey residual soil. The intense weathering occurs along a zone that parallels the schistosity planes and a major fault plane trending NS. The fault zone provides the weak zone where water seeped into the ground. Therefore e intense weathering preferentially occurs along the zone.

The slope failure occurred along a V-shaped slope (Figure 8 D) that have undergone continuous failures as indicated by the fallen drains and disrupted benches. Continuous failures are concentrated along the fault zone parallel intense weathering zone giving rise to a V-shaped valley.

All failures occur along the V-shaped, oversteepened slopes. These slopes are critically unstable. At the main landslide the headscarp (slope B) is oversteepened at a slope near to 90 degrees. Presently, the entire headscarp region is extremely unstable. Erosion is continuously taken place along the intensely weathered zone. Sliding occurred along moderate southerly dipping joint planes and wedge failures occur as a result of intersection of foliation with releasing joint surfaces giving rise to southerly plunging wedges.

Erosion and failures along the axial weathered zone resulted in undercutting of the over steepened slopes. These result in the side slopes (slope A and C) to fail. Failure along these side slopes occurred by sliding along foliation planes and day lighting wedges created by intersection between foliation and joint surfaces.

Based on the analysis as shown by the Markland's tests for failure (Figure 8 C), the slope is susceptible to planar and toppling failures. Wedge failure may occur along the intersection of joints.

- geologic map showing the slope failure geometry and distribution of discontinuities.
- cross section showing sliding planes
- photographs showing the discontinuity controlled slope failure
- slope stability kinematic analysis results.
