## Engineering Geology of the Kota Kinabalu Area, Sabah, Malaysia

Rodeano Roslee, Sanudin Tahir & S. Abd Kadir S. Omang

**Abstract:** The geology of the Kota Kinabalu area provides a favourable setting for engineering geological instability. Kota Kinabalu is underlain by the Late Eocene – Early Miocene Crocker Formation and Quaternary Alluvium. The Crocker Formation is composed of thick sandstone unit, interbedded sandstone – shale unit and shale unit. These rock units are dissected by numerous lineaments with complex structural styles developed during series of regional Tertiary tectonic activities. The tectonic complexities reduced the physical and engineering properties of the rock masses and produced intensive displacements and discontinuities among the strata, resulting in high degree of weathering process and instability. The weathered materials are unstable and may cause subsidence, sliding and falling induced by high pore pressure subjected by both shallow and deep hydrodynamic processes. This paper describes the engineering geological investigation, appreciation of the complex geology, examination of material properties under specific geological laboratory tests, field t

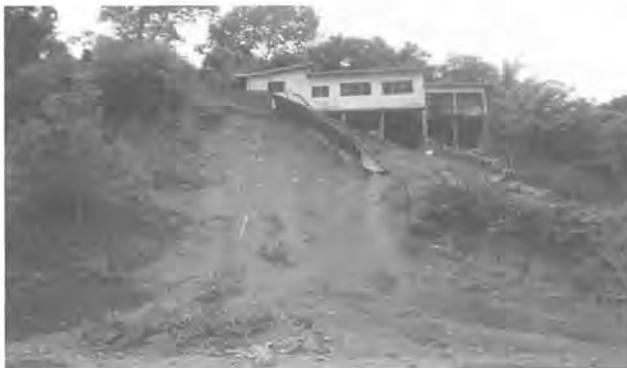
**Figure 4.** Slope failure at Bundusan road, Luyang

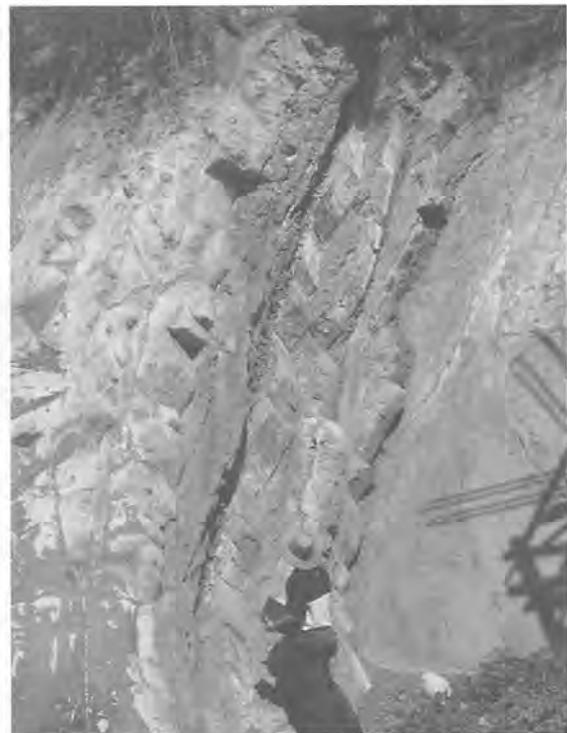
**Figure 5.** Grade III to IV sandstone and shale of the weathering profiles (Location: Survey Hypermarket, Likas)

The layered nature of the sandstone, siltstone and shale of the Crocker Formation may constitute possible sliding surfaces (Fig. 5). The sandstone-shale contact is easily accessible by water and such contact seepage may weaken the shale surface and cause slides and falls within the formations which dip away from the foundation (Fig. 9). Severe uplift pressures may also develop beneath shale beds in foundation sites and appreciably reduce its resistance to sliding. Interbedded sandstone, siltstone and shale may also present problems of settlement and rebound (Fig. 7). The magnitude, however, depends on the character and extent of shearing in the shale.

The bearing capacity of the Crocker sandstone is reduced by the absence of chemical cement (vein) and the presence of discontinuities (Fig. 5). This rock type should be carefully evaluated in each development area so as not to be misled by the theoretical strong behaviour of the sandstone material.

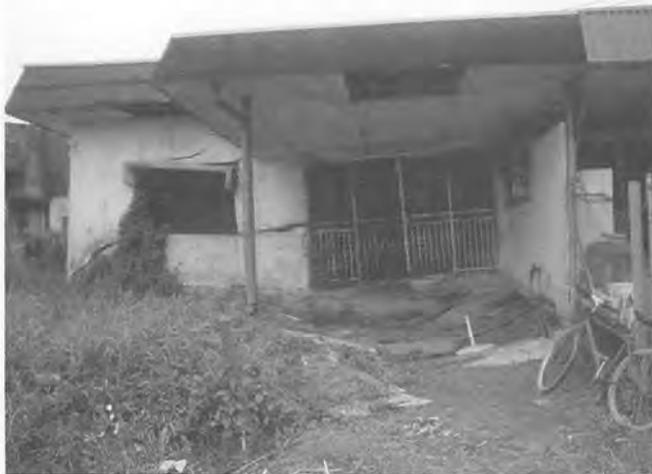
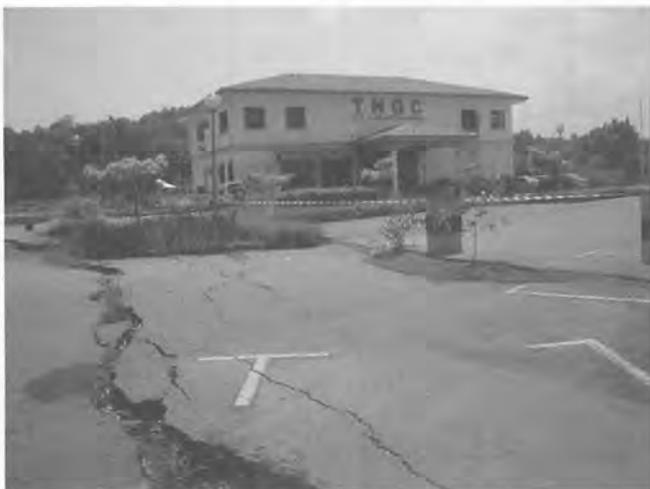
**Figure 7.** Land subsidence occurrences in the Crocker Formation (Locations: a) Taman Landmark, Penampang and b) TNGC Recreation Centre, Bundusan)

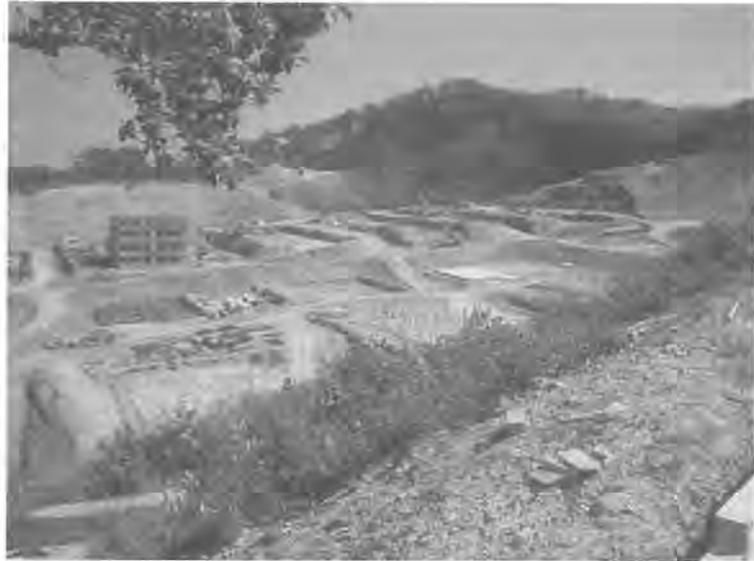
**Figure 8.** The cutting of hill slope, removing trees and vegetation from the hill slope reduces the stability of the slope. (Location: Kibabang road, Penampang)

The cutting of hill slope, dumping of the stream within or along the slope and removing trees and vegetation from the hill slope reduces the stability of the slope. As a result the hill slope becomes critical/unstable (Fig. 8).

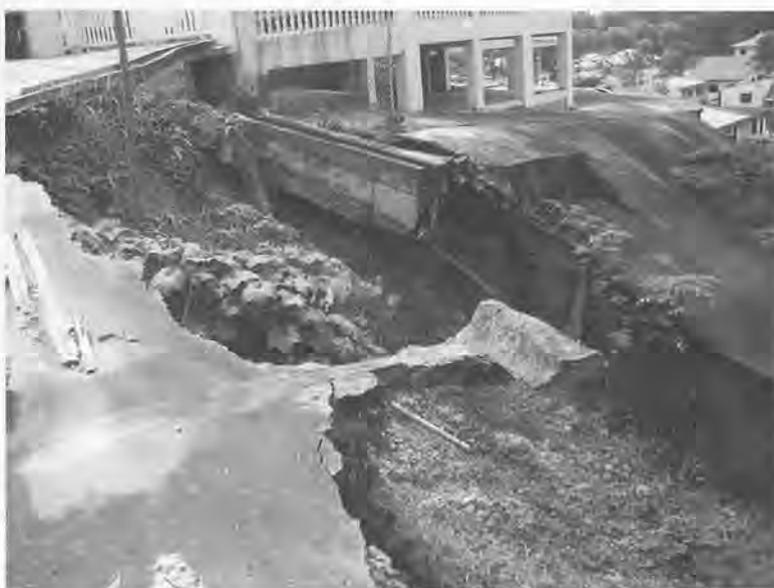
the deformed weathered hilly slope. Talus deposits which cover the lower slope in hilly areas are highly permeable, unstable and susceptible to slope failures. This site should be avoided as possible from locating any prospective foundation site (Fig. 9).

**Figure 9.** Foundation problems associated with the Crocker Formation (Location: Bukit Padang)
