## Blasting-induced rock slope instability in Senai, Johor – a preliminary post-construction assessment

**Abstract:** A new railway line was constructed recently in the state of Johor, Malaysia to link the Senai Airport and the newly built Tanjung Pelepas Port. Its alignment transverses some hilly terrain and thus resulted in the formation of a number of major cut slopes. One of them is a 35m high slope near Senai, Johor, which is cut in bedrock of the Late Cretaceous-Early Tertiary Pulau Granite. A preliminary post-construction geological assessments carried out on the rock slope indicate that most of the unstable elements are mainly due to excessive and poor blasting practice. Overblasting has resulted in widening of major joints, excessive overbreaks, unstable and loose overhanging blocks. Results of kinematic stability analysis on the discontinuities indicate that the rock slope has the potential to undergo planar, wedge and toppling failures. Rock falls could also take place by over toppling. Excessive overbreaks and fragmentation of the rock mass could be minimised if a proper geological appraisal on the bedrock was carried out beforehand, and suitable blasting practice adop

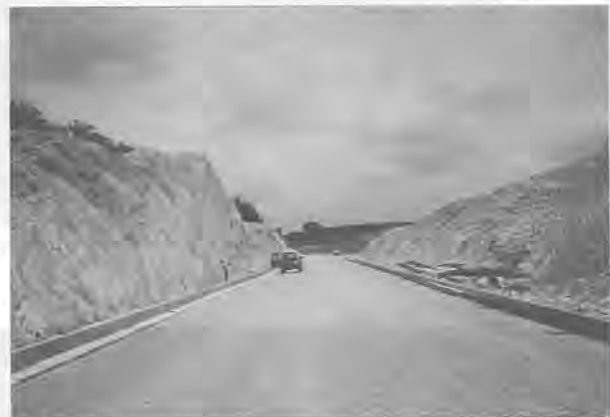
Plate 1: View of rock slope in study area

In the exposed rock cut, the weathering grade of the granite ranges from slightly weathered to fresh *i.e.* Grades II to I. The bedrock is overlain by soil derived from in-situ weathering of the bedrock. The soil mainly consists of silty SAND to sandy SILT and is reddish to yellowish brown in color. This soil material can be classified as residual soil to completely weathered rock *i.e.* Grades V to VI. The depth and thickness of soil and weathered material changes to fresh rock is extremely variable as can be seen in the slope exposures (Plate 1).

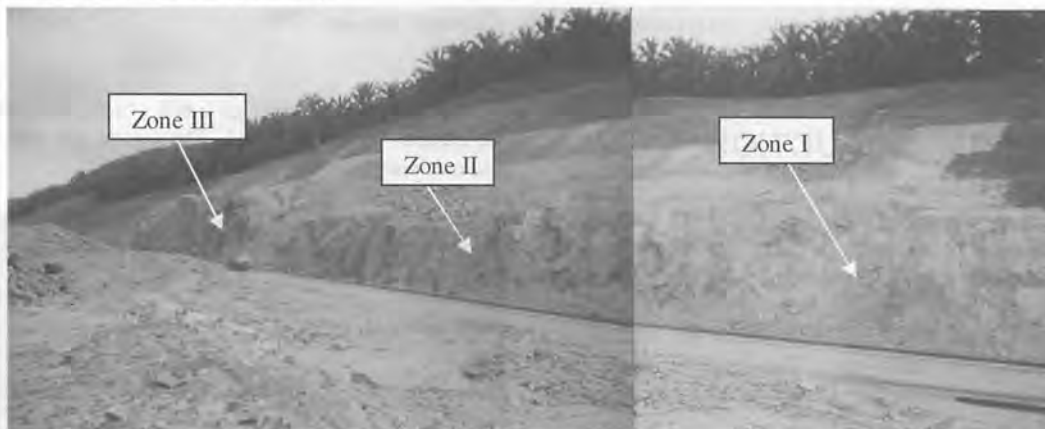
Plate 2: Overall view of the right hand side cut rock slope

The study area was divided into two slope sections namely Right Hand Side (RHS) and Left Hand Side (LHS), the left and right hand sides being named while facing toward increasing chainage i.e. toward Port of Tanjung Pelepas. Overall views of the RHS and LHS slope faces were shown in Plate 2 and 3 respectively.

For rock slope with combination of highly jointed rock and potential single block failure can be fixed with wire mesh anchored to the rock slope face. This measure suitable for area at RHS slope and for the lower slope face area at LHS slope. The estimated area required for this measure is approximately 1800m<sup>2</sup>.

Rock dowels should also be considered as one of the mitigation measures. This measure can be applied through out the slope face either RHS or LHS slope. The estimated numbers of rock dowels to be installed shall be approximately 80.

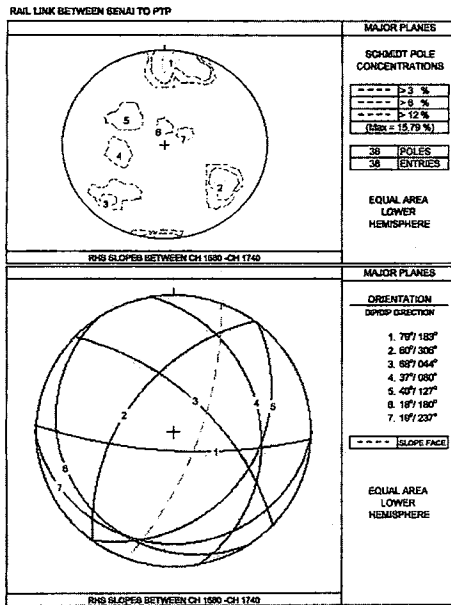
Figure 1: Stereoplot for RHS Zone I

There are seven discontinuity sets for this zone. However, three sets i.e. set J1 with dip and dip direction of 79/183, J2 (60/306) and J3 (68/044) can be considered major while others i.e. J4 (37/080), J5 (40/127), J6 (18/180) and J7 (19/237) are minor. Intersection of the discontinuity planes produced a potential for wedge failures, while the J2 and J6 planes will also act as the main release planes. The stereoplot presented in Figure 1.

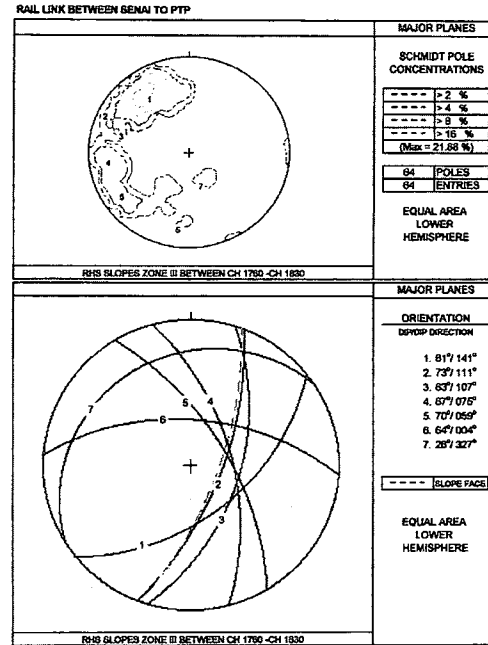
Figure 3: Stereoplot for RHS Zone III

(63/107), J4 (67/075) and J5 (70/059) while the minor sets are J6 (64/004) And J7 (26/327). Potential wedge failures can be produced by intersection of J1 and J3, J4, J5 or J6. The J2 and J3 planes can produce potential planar failure planes. The J7 plane can act as release plane for all potential wedge failure planes. Stereoplot is presented in Figure 3

The distribution of discontinuity sets mainly concentrated within 20meters of the slope face while another 50 meters the slope face is massive without many discontinuity sets. There are seven discontinuity sets in this zone. The major sets are J1 (61/141), J2 (73/111), J3

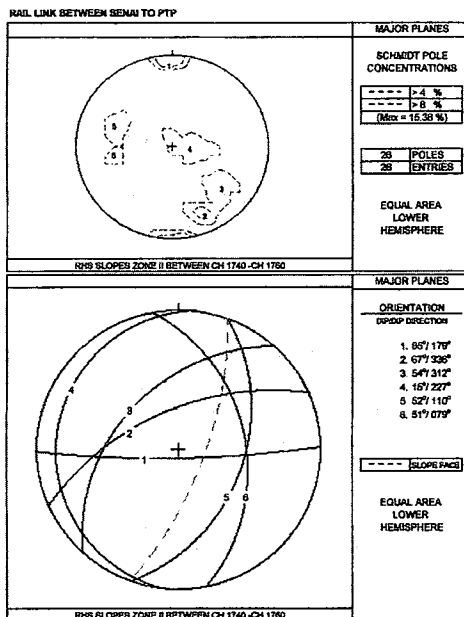
Figure 2: Stereoplot for RHS Zone II

There are six discontinuity sets in Zone II. Only 2 sets can be considered as major i.e. J1 (85/179) and J2 (67/336) while the minor discontinuity planes are J3 (54/312), J4 (15/227), J5 (52/110) and J6 (51/079).

Intersection of J5 and J6 plane can produce potential wedge failures while J5 plane itself can produce potential planar failure plane. The J4 plane has a potential to produce toppling failure plane and can also react as a release plane to the wedge failure plane intersected between J5 and J6. The stereoplot is presented in Figure 2.

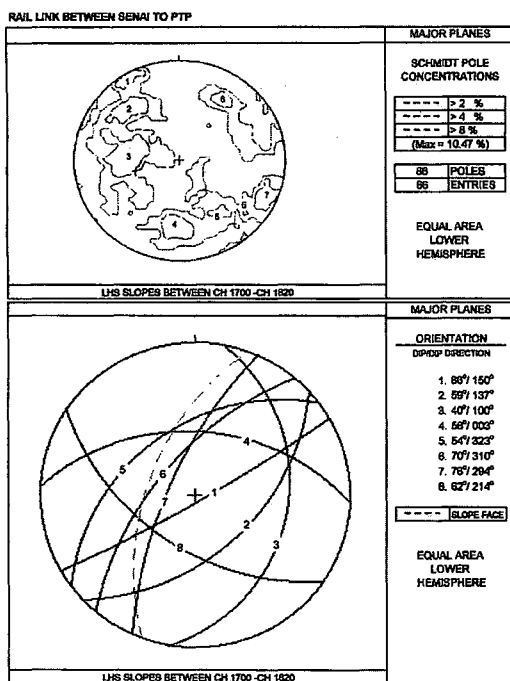
Figure 4: Stereoplot for LHS Slope

This slope face has 8 discontinuity sets. All of the discontinuity sets can be considered as major sets based on their density, though, not all of them contribute to potential instability. Potential wedge failures can be produced by the intersection of J5 and J8, J4 and J8, J6 and J8, J1 and J6 and J1 and J5. J3 plane can produce potential planar failure plane while J7 can act as release plane for all potential wedge failure planes.
