A hazard assessment of a granite cut-slope in a hillside development off Jalan Kuari Cheras, Selangor

MUSTAFA KAMAL SHUIB & TAJUL ANUAR JAMALUDDIN

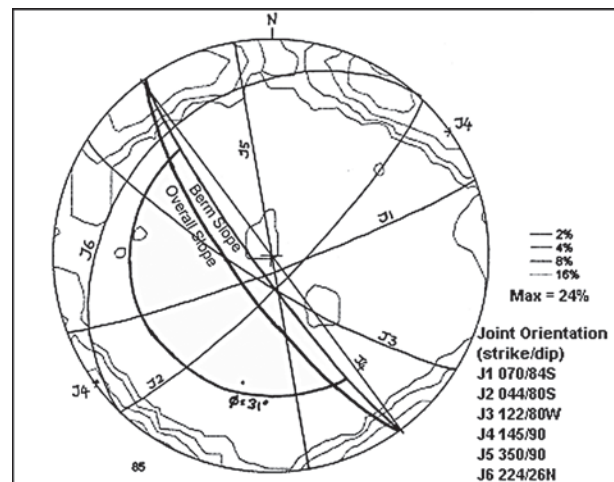
Based on the discontinuity survey (Figure 2), 4 major joint sets (namely J1, J2, J3, J4) plus one set of minor joint (J5) and a set of sheet joint (J6) were identified. The northwesterly trending sub vertical major joint sets (J3 and J4), are striking nearly parallel to the slope face, while the northeasterly trending sub vertical joints (J1 and J2) transect the slope surface almost at right angle. The sheet joint dips gently (20-25°) to the NW (314°) into the slope and thus are not likely to pose instability problems to the rock slope.

Results of the kinematics stability analysis of the slope are given in Figure 2. The shaded region (area bounded by the friction circle and slope face) in the stereoplot is the considered a critical area. Results of the analysis (Figure 2) indicated that:

- The overall (global) rock slope is generally stable. No sign of major instability was detected on the slopes. The orientations of the major joint sets is generally favourable to the slope orientation with the exception of the sub-vertical J4 joint set that may give rise to toppling.
- However, potential localized small-scale wedge failures are possible on the berm slopes due to the intersections of joints sets J1xJ3 and J2xJ3. Details of these localised unstable elements and the recommended methods of stabilization/protection are summarized in Table 1.

Figure 2. Kinematics stability analysis of the rock slope.

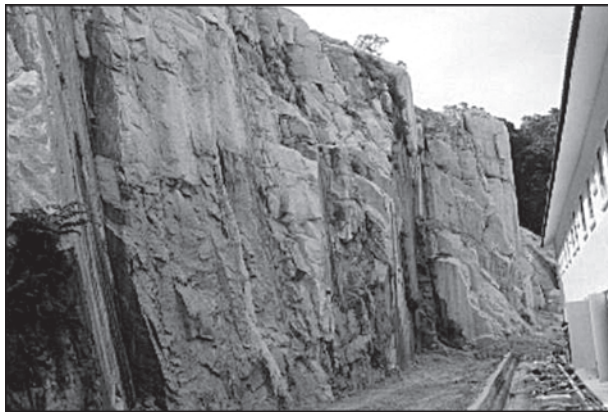
One example of a hillside residential development that is of concern to the authorities is a rock slope off Jalan Kuari in Cheras. The rock slope was identified as being potentially unstable. The stability of this particular slope was critical because it was located immediately across the backlane behind a row of newly completed terrace houses. Figure 1 gives a general view, showing the steep rock slopes on the left and the row of terrace houses on the right.

The rock slope under consideration is situated along the back lane of a row of terrace houses. The rock slope cutting is about 160 m in length and about 20 m high. The bench slope angle is nearly subvertical ($>85^\circ$), but the overall (global) rock slope angle measured about 75° . The

Figure 1. View of part of the steep granite cut slope behind existing row of terrace houses.

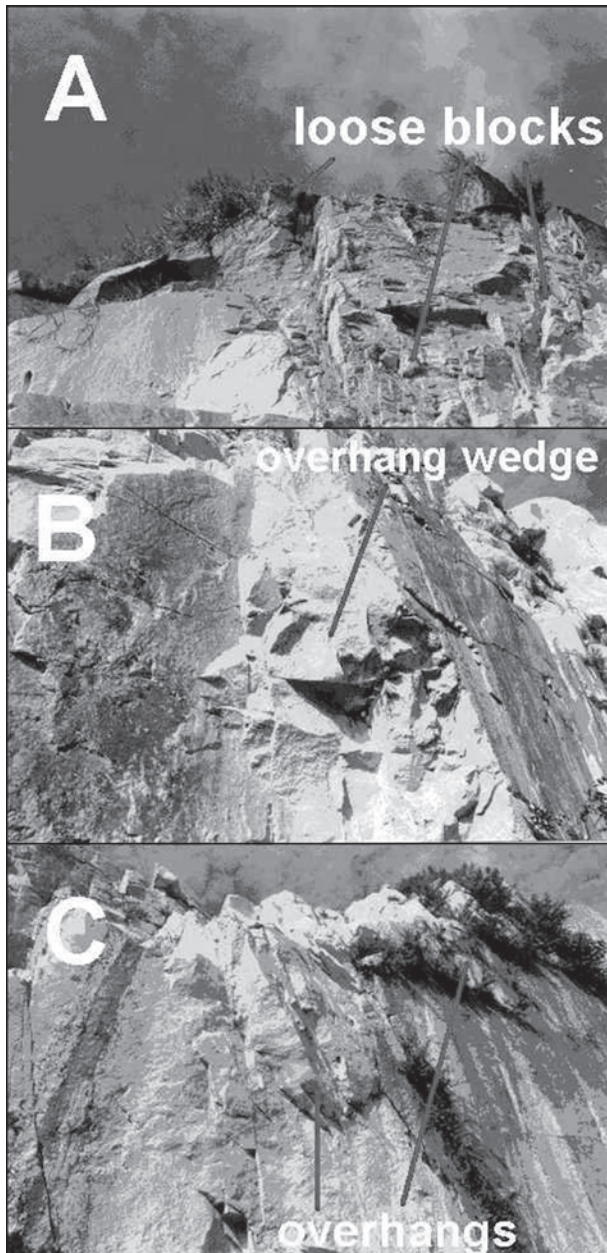
From this study, it can be concluded that the rock slope behind the newly completed terrace houses is generally stable. No signs of major instability were found except that for some localized small-scale unstable elements (Figure 3) as summarized in Table 1. These unstable elements could be easily removed from the slope or protected with the protection/stabilization measures recommended in Table 1. A qualified geotechnical engineer or engineering geologist should be engaged to supervise the slope stabilization/protection works.

Figure 3. Examples of unstable elements on the cut slope before remedial works were undertaken. A) Loose blocks on top of the slope; B) overhang wedges; and C) overhang blocks.

Table 1: Summary of localised unstable elements in the rock slope and the recommended remedial measures.

Nos	Chainage (Refer to red marker at the foot slope face)	Unstable Elements	Estimate Size	Recommended Stabilisation/Protection Measures
1.	17m – 20m (lower berm)	Overhanging slab	3m x 4m x (0.5 – 1.0)m	Rock dowel

2.	22m – 24m (lower berm)	Overhanging wedge	1.5m x 2m x (0.3 – 1.0)m	Scale off
3.	22m – 24m (upper berm)	Overhanging wedge	Small (<1.0m ³)	Scale off
4.	39m (lower berm)	Overhanging wedge,	Small (<0.5m ³)	Scale off

5.	39m (upper berm)	Loose, heavily fractured rock	2m x 2m x 1m	Wire mesh + shotcrete (area: 5mx 3m)
6.	60m (upper berm)	Overhanging wedge/block, on a daylighting, wet joint	3m x 2.5m x 3m	Rock bolt + concrete dentition

7.	75m – 79m (lower berm)	Overhanging wedge, bounded by wet joints	6m x 4m x 3m	Rock bolt
8.	90m – 91m (upper berm)	Overhanging slab, daylighting	0.5m x 1.5 x 0.4m	Scale off

9.	103m – 106m	Daylighting wedge, wet, daylighting open joints	1.5m x 1.5 x 1m	Concrete dentition to support the overhanging wedge.

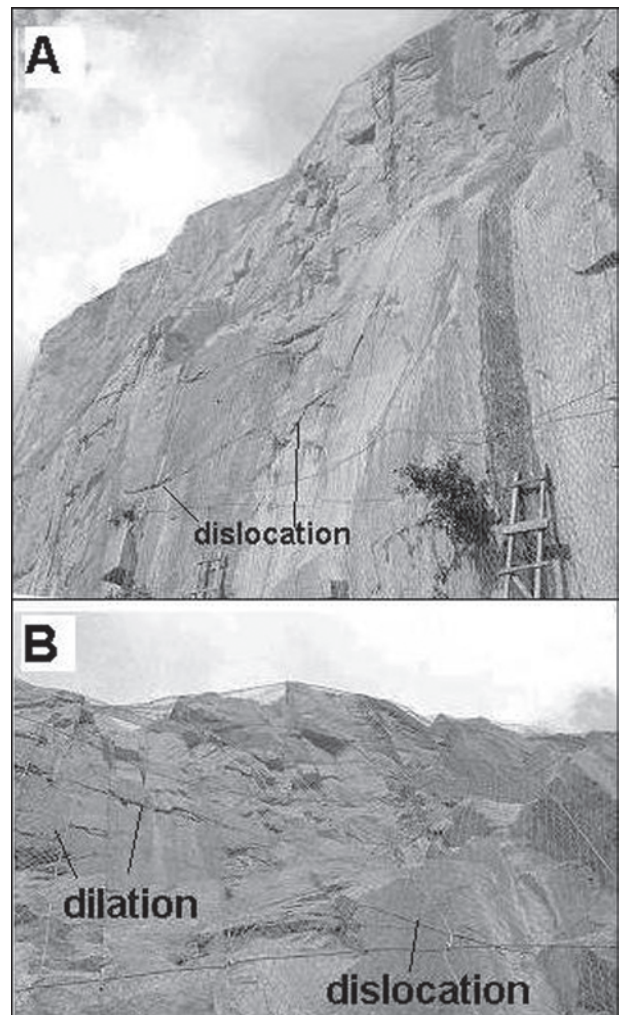
After the remedial actions were taken the slope was further inspected and monitored. It was found that dilations

Figure 4. Examples of instabilities created after the stabilization works.

and other signs of displacement had occurred along some joints in certain blocks developed during and after the stabilization works (Figure 4). Further remedial works should be undertaken to ensure the long-term stability of the slope and in the meanwhile the slope should be monitored regularly for signs of instability.

Monitoring slopes of concern is commonly an interim, precautionary measure while other action is being taken to remedy the cause of concern so as to make the slope safe over the long term. After the completion of the additional remedial works, monitoring is no longer necessary but instead regular maintenance should be carried out.
