## **The slope stability problem at Mae Moh Lignite Mine, Lampang Province, Northern Thailand**

W. TANDICUL<sup>1</sup>, N. MUANGNOICHAROEN<sup>2</sup>, and N. GUMPERAYARNNONT<sup>3</sup>

<sup>1</sup>Lignite Mine Department, EGAT, Bangkok.

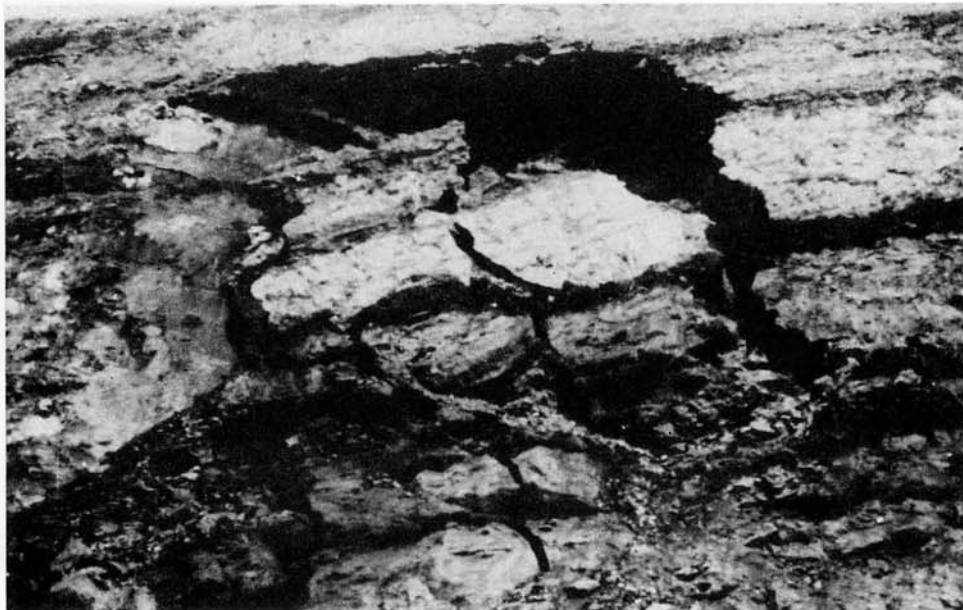
In March 1980 the first wedge failure (Figure 4) was observed on the lower bench by Pramote Pornrattanapitak, a geologist of EGAT (1981, personal communication). The wedge was 18 m high and 20 m long and was controlled by a fault striking NNW and dipping 35° NE which intersected an irregular vertical joint trending ESE.

Fig. 4. A wedge failure on the northwestern pit slope in March 1980 (Courtesy of Mr. P. Pornrattanapitak of EGAT).

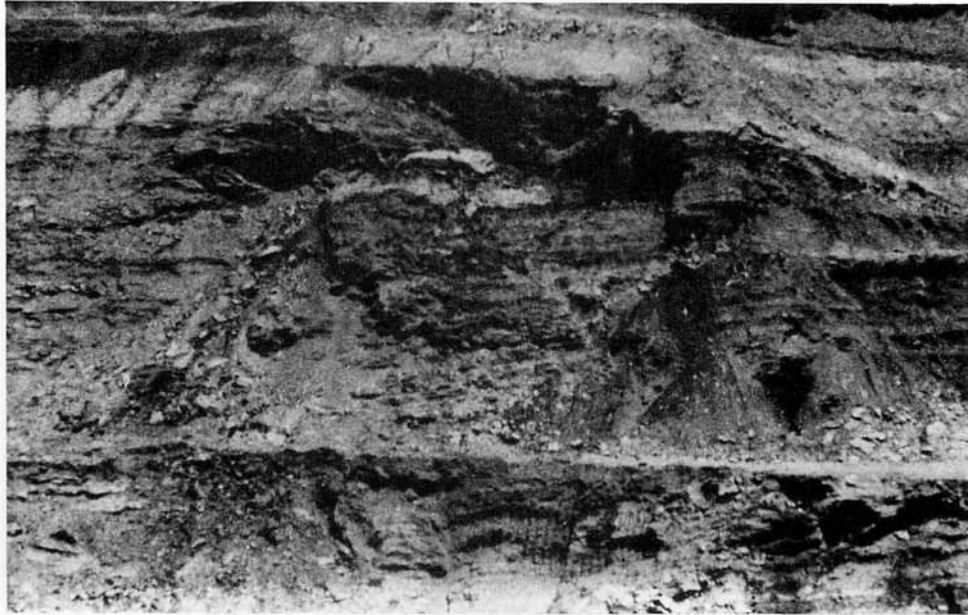
The wedge grew larger with the help of alternating wet and dry seasons. In March 1981, during this investigation, further sliding of the wedge was noted along the intersection line of the above mentioned discontinuities (Figure 5).

Fig. 5. The continuation of the 1980 wedge failure (Figure 4) as observed in March 1981.

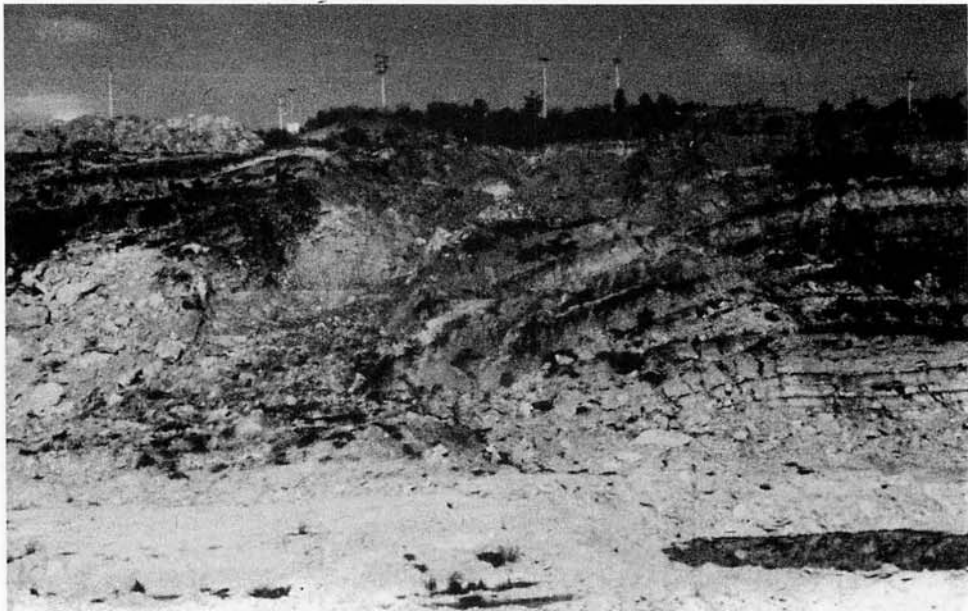
Fig. 6. A major land slide which followed the wedge failure (Figures 4 and 5) had occurred in August 1981.

The following months were well into the rainy season. At the peak of the season, August 1981, a major landslide took place. The sliding mass was found to be of a circular failure type. The mass was about 250 m long along the slope face (Figure 6).

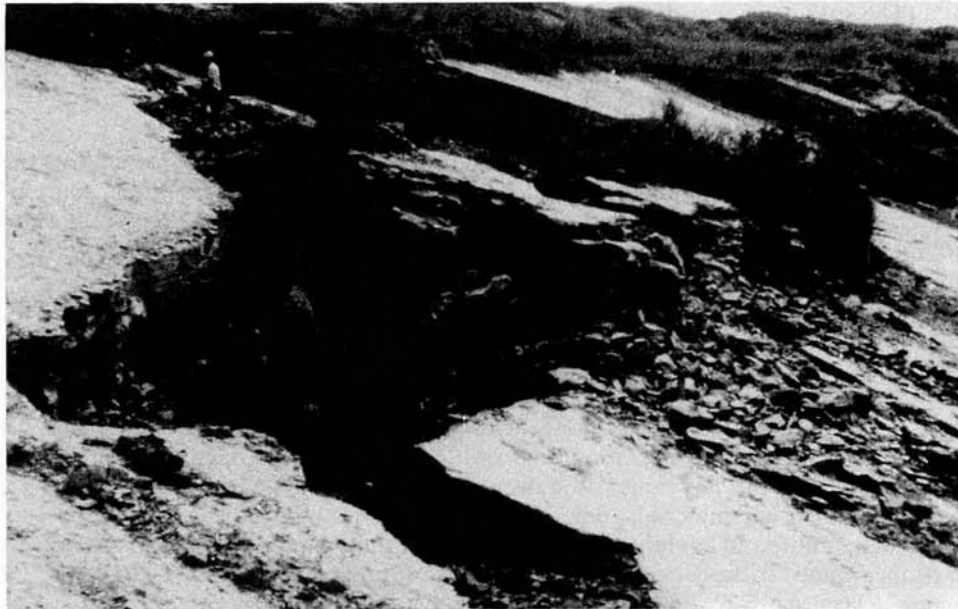
Fig. 7. The planar slides on the southeastern slope. The sliding blocks move along the bedding planes which dip gently into the mine pit.

On the opposite side of the pit where the bedding planes dip gently into the mine, i.e., transecting the northwestern-facing slope, planar slides are very common (Figure 7). The sliding blocks, sometimes as huge as 400 m<sup>3</sup> move downdip along the bedding planes of the claystone with the help of the joints which are perpendicular to the bedding planes and strike either perpendicular to or parallel to the slope trend.
