# Reactivated ancient slides at the Sungai Kelalong Dam site, Bintulu Sarawak, East Malaysia

#### TAJUL ANUAR JAMALUDDIN

Geological Society of Malaysia, Bulletin 49, April 2006, p. 5-11

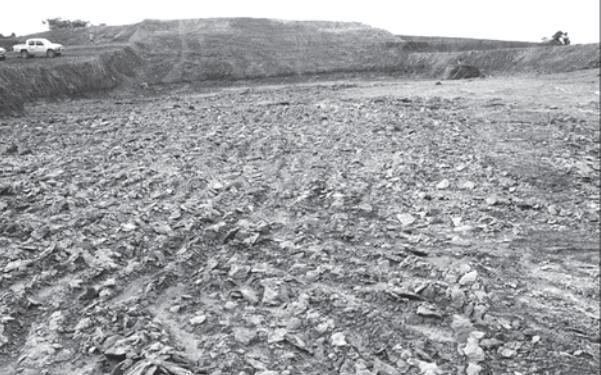
**Figure 2.** View of the early-planned foundation for the spillway. The bedrock is predominantly thinly bedded mudstone-siltstone interbedded with thin fine sandstone (camera facing upstream, June 2002).

The spillway foundation, measures about 30 m wide and 195 m long and was excavated into thinly interbedded mudstone and fine sandstones. Along the entire length of the spillway axis, the predominantly grade III rock mass is very gently dipping (5°-10°) to the SSW (Figure 2). Grade IV, V and VI rocks are only exposed in both the left and right side walls of the spillway channel.

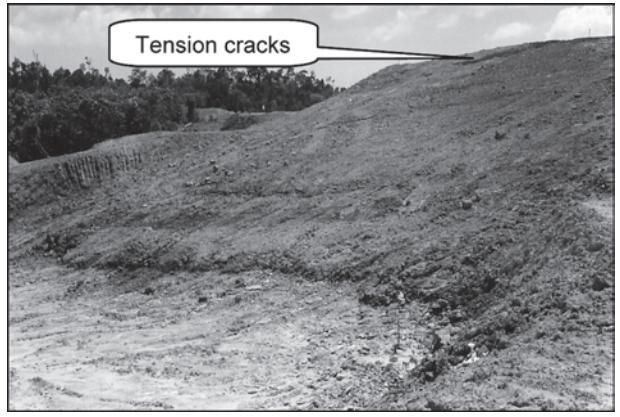
**Figure 3.** Bulging along the toe of the spillway slope – a clear evidence for slope movement.

The spillway slope failure took place at the end of May 2002 in the form of massive landslides after a few days of prolonged rainfall. The failure affected almost two-third of the spillway slope (Figures 3 & 4) and also badly damaged part of the neighbouring core trench wall of the main dam (Figure 5). On the spillway side, the landslide resulted in a marked toe bulging (Figure 3) and widely open (up to 30 cm wide) tension cracks associated with measurable vertical drops (about 20-30 cm) that

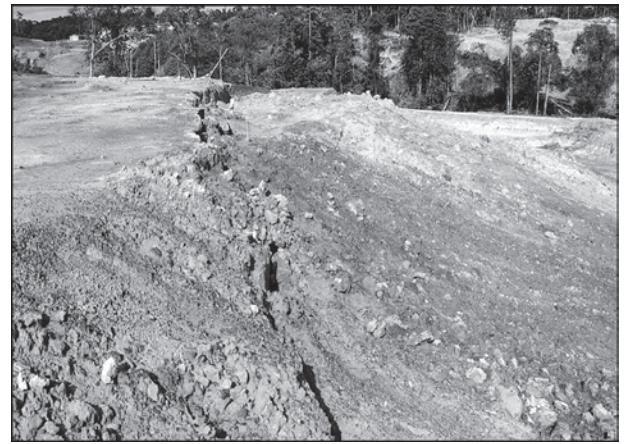
Figure 4. The failure scarp of the landslide on the spillway slope.

dissected the upper slope and spillway crest in an almost E-W direction (Figure 4). The tension cracks can be traced for more than 50 m in length along strike and was actually developed along a major fault zone striking almost E-W. The fault zone itself is characterised by a 20-25 m wide belt of subvertical open fractures (Figure 6) and sheared rocks, often filled up with reddish brown iron oxides and lateritic materials, running subparallel to each other in 095-110° direction as seen on the floor of the right wing dam foundation between CH650-CH680. The fault zone is also marked by a sudden change in the weathering grade of the rock mass as seen in the nearby excavation wall (Figure 7). The rear scarp of the landslide and the associated tension cracks were actually developed along this subvertical fault zone.

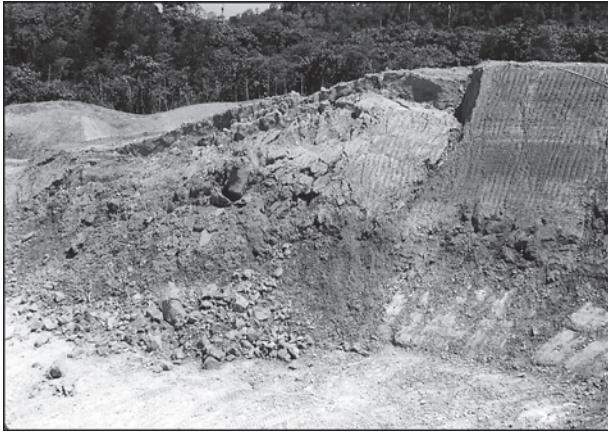
Figure 5. Side view of the same landslide which also badly affected the core trench wall of the main dam foundation.

On the left of the spillway, the same landslide has also badly affected the core trench wall of the main dam foundation. The landslide looks more severe on the core trench wall because the cut face is steeper (about  $80^{\circ}$ ) than the spillway slope (about  $22^{\circ}$ ). Viewed from core

trench side (Figure 5), the failure scarp can be clearly seen bounded by the subvertical E-W fault zone described above.

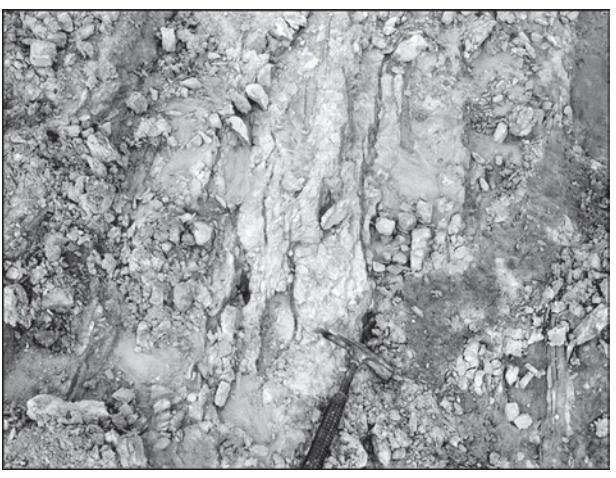
**Figure 6.** Close-up plan view of the closely spaced, open and subparallel fractures within the E-W striking fault zone, along which the tension cracks and the rear sliding plane for the failure were developed.

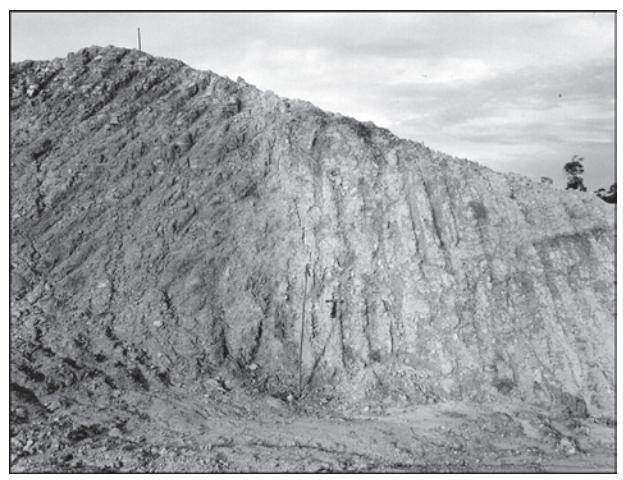
**Figure 7.** Note the sharp and sudden contrast in the weathering profile which indicate the profound structural control by the major fault zone referred to in Figure 6.

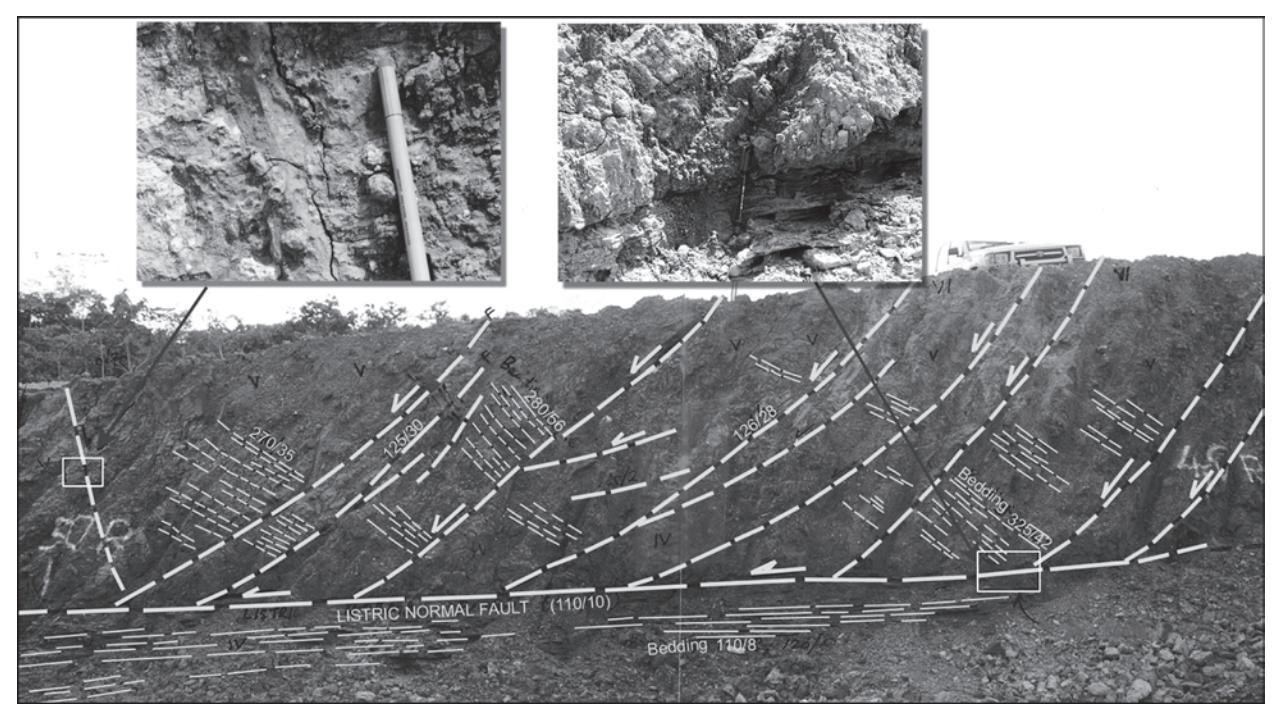
Figure 8. A major low-angle listric normal fault as exposed in the right wall of the Spillway excavation site. Insets show the close-up view of the individual fault plane.

A special post-mortem fieldwork was conducted in early June 2002, about a week after the failure took place, to investigate the causes for the landslide. Based on close inspection, it was found that the site of the spillway foundation is located within a package of an ancient slide, which has been totally weathered into grade IV to grade VI materials. This is evident by the presence of a major, low angle, basal sliding plane which resembles much of a "listric normal fault" system as shown by McClay & Ellis (1987) in their experimental analogue modellings.The listric normal fault plane is oriented subparallel to the bedding planes, and it was encountered just a few dm above the spillway floor level (Figure 8).This basal fault,

which represents a relict sliding plane; is well exposed on the right-side wall of the spillway channel and is marked by about 10 cm thick band of sheared rocks. Above the basal fault, the rocks are highly disturbed and tilted due to fault block rotation, showing marked contrast with the bedding below the basal fault. Above the basal fault, the bedding planes are moderate to steeply dipping towards N-NE and are dissected by numerous smaller normal (antithetic and synthetic) faults. These antithetic faults and the smaller fault splays are syn-tectonic and linked to the underlying major listric normal fault plane.

Due to the massive failure on the spillway slope, the preliminary design of the spillway was revised. In the revised design, the foundation level was excavated deeper into grade II - grade III sandstone-dominated sequence, well below the level of influence of the listric fault and thus the potential for slope instability caused by the presence of this fault can be greatly minimised. The sandstone is generally light grey to creamy white, thinly bedded, sometimes contain very thin dark/black laminations of carbonaceous material/flakes. The bedding attitude in general dipping 10-12° to SSW. The sandstones are generally medium strong to strong rocks (Tajul Anuar Jamaluddin, 2003). Figure 11 shows the level of the listric fault with respect to the final level of the spillway foundation as in the revised design. Without the influence of the listric normal fault, the subvertical E-W striking fault alone is less likely to cause instability to the spillway slope.

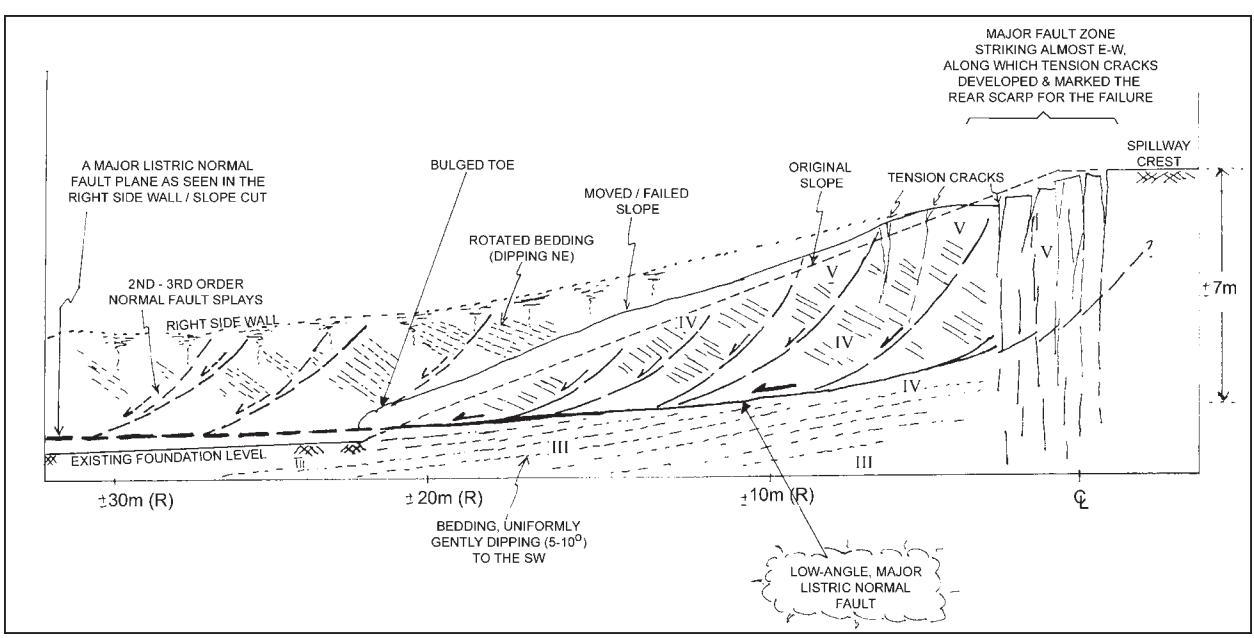
**Figure 9.** An idealised sketch (not to scale) showing the interpretative geological section along the Spillway axis. The slope failure is attributed to the presence of a major, low angle listric normal fault (an old sliding plane) which intersecting with the subvertical E-W fault zone.

track under the spillway slope and the failed mass. It is strongly believed that this fault intersected with the subvertical fault zone described earlier, resulted in the formation of unfavourable massive wedge for the sliding to occur (see Figure 9) . The listric normal fault plane, once probably acted as a sliding plane of an ancient submarine slide, has now become reactivated by the current engineering activities in this area. This explains why the slope movement primarily took place in the spillway downstream direction rather than towards the core trench slope cut on the left, even though the spillway slope is much gentler (about 22°) compared to the core trench slope cut (about 80°). The whole picture of the slope failure is illustrated in a block diagram shown in Figure 10.

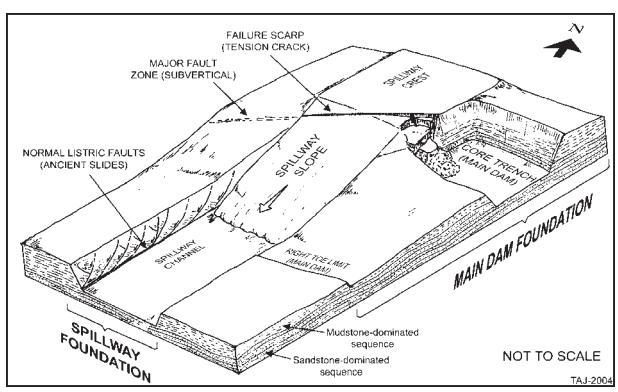
Figure 10. An idealised 3-D sketch to show the overall picture of the massive landslide which badly affected the Spillway foundation.

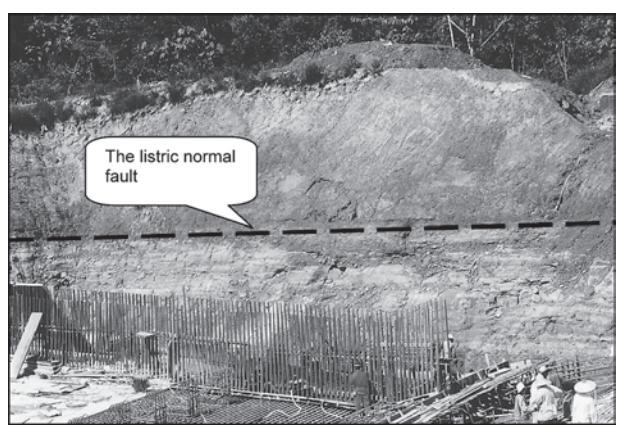
**Figure 11.** View of the right wall of the Spillway. Note the level of the problematic listric normal fault with respect to the current Spillway foundation level.
