Influence of discontinuity on overbreaks and underbreaks in rock excavation — case study from Beris Dam, Kedah, Malaysia

TAJUL ANUAR JAMALUDDIN AND ISMAIL YUSOFF

Geology Department University of Malaya 50603 Kuala Lumpur

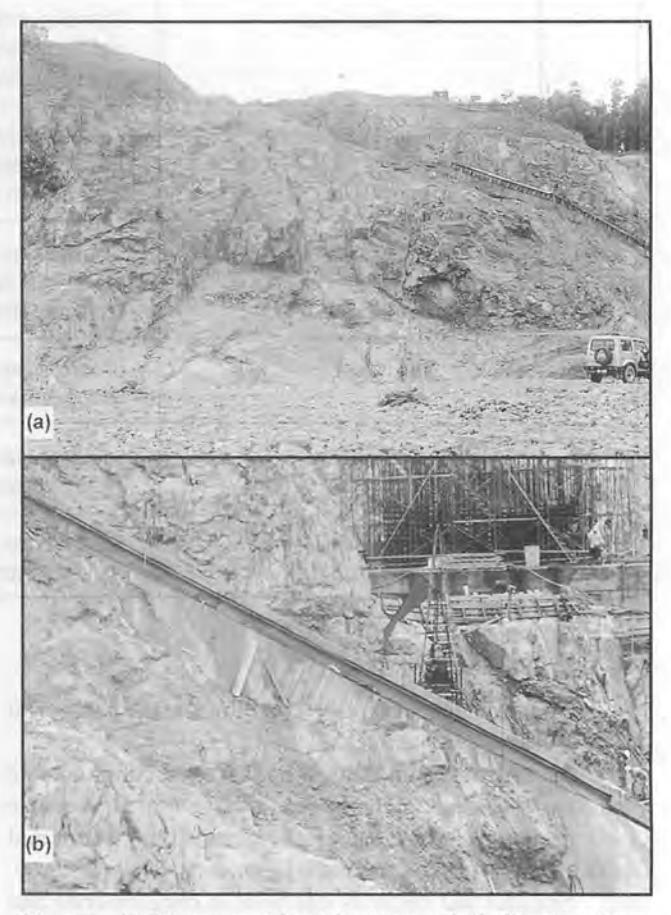
The discontinuities are mainly found in the form of joints; although faults, bedding planes and shear zones were the most persistent (see Tables 2 and 3). Due to intense jointing and shearing, the rock mass is characterised by polygonal block shapes of variable sizes, ranging from as small as several cm³ to up to 1.5 m³. Intersections of the major joints give rise to highly irregular bedrock surface. This can be clearly seen in both the left and right abutments

Plate 2. (a) View part of the right abutment hill of the Main Dam. Note the highly irregular bedrock surfaces due to intense jointing. (b) Part of the overbreak in the bedrock founding the toe slab on the right abutment of the Main Dam as indicated by the irregular thickness of the concrete base.

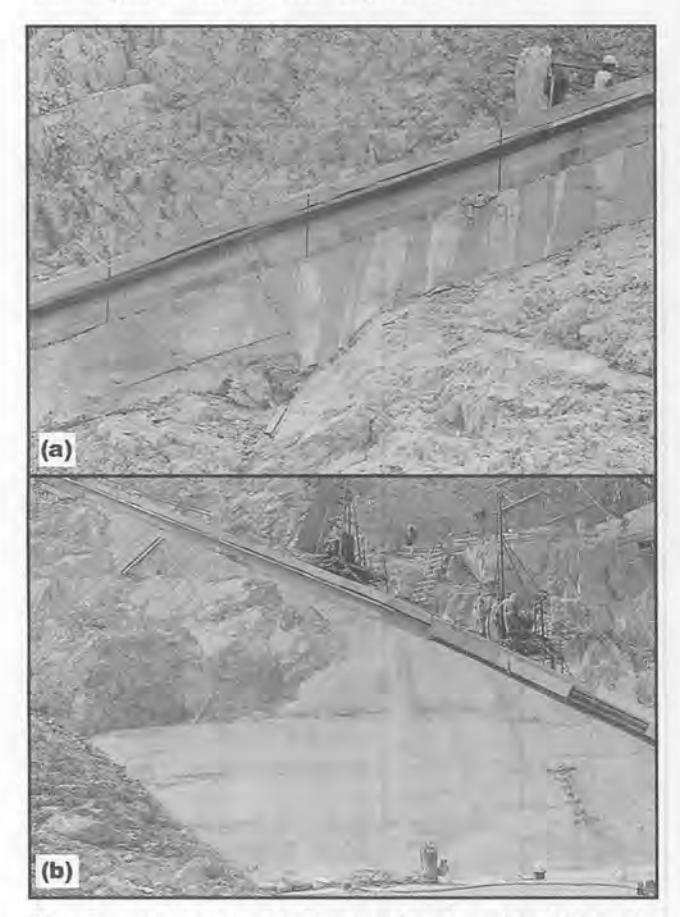
slopes (Plate 3a) as well as along the base of the toe slab (Plate 3b). Irregularities in the bedrock surface profiles clearly suggest that the discontinuities exert profound control on the breakage behaviour of the rock masses.

Plate 3. (a) An example of wedge-shaped overbreak below the toe slab on the left abutment of the Main Dam. (b) Part of the major overbreak (now fully backfilled with concrete) below the toe slab on the right abutment of the Main Dam.

Along the left toe slab, unstable wedges were naturally well developed due to the intersections of J6xJ4 and J6xJ3 joint sets. Joint set J4 would have served for the sliding of rock slabs (planar failure), while joint set J1 is responsible for toppling or rock falls in the rock cuts intended by the blasting line. Along the right toe slab; wedge failures were taken place along the intersection of J1xJ3, J1xJ2, and J2xJ3. As an example, the rock slide, which caused a major overbreak shown in Plate 4a, is attributed to the presence of daylighting J2 joint set. Some examples of joint-controlled overbreaks indicated by these analyses are clearly evident in the field as captured in Plate 4.

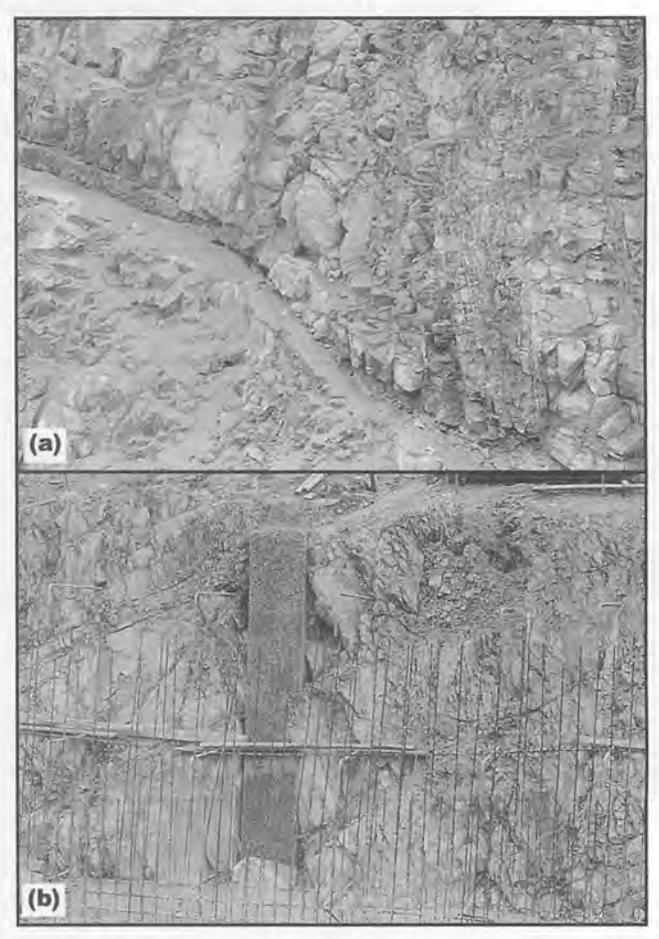
Plate 4. (a) Note the highly irregular and jagged rock surface due to intense jointing and shearing of the bedrock, which is further aggravated by blasting effects (Spillway left wall). (b) View part of the right wall of the Spillway. Note the highly persistent bedding planes and intense jointing in the rock mass.

An almost similar case is found in the right wall (Plate 4b). Elements of rock instability naturally exist in the rock mass due to intersections of J2xJ7, J1xJ7 and J1xJ6, which are responsible for overbreak in the form of rock wedges. While set J4 and J5 can easily produce block toppling or rock falls during and/or after blasting operation. A clear example of wedge overbreak in the Spillway is shown in Plate 6-7.

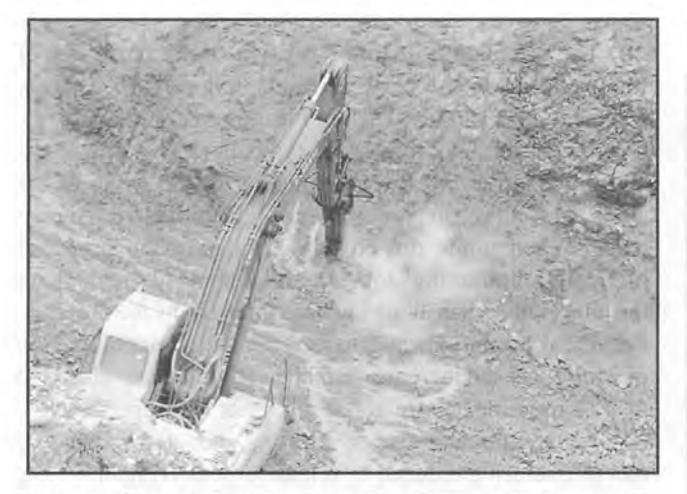
Rock excavation in the Spillway was conducted by adopting pre-split blasting technique – where a closely spaced with small diameter blastholes were drilled along the line of the final face. The trimming of underbreak to the final wall surface was executed by machine excavation (pneumatic rock breaker, e.g. Plate 5). The blast holes were drilled at approximately 70°, along the line of the toe of the proposed bench. The intention was to result in the formation of a clean fracture running from one hole to the next. However; this was not always the case because the resulted faces can also be irregularly rough and jagged due to overbreak and underbreak which inevitably modify the Spillway dimensions off the original design.

Plate 5. Trimming of the blasted surface in the plunge pool section of the Spillway.

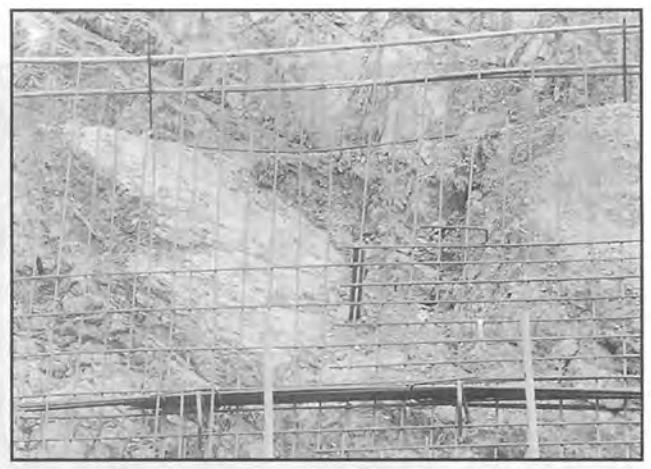
In order to assess the influence of the geological structures upon the formation of blasting overbreak, kinematics stability analyses (Hoek and Bray, 1981) was adopted on the discontinuities data collected from the right and left wall of the Spillway (Fig. 4a and 4b). From these analyses it was found that the left wall (cut slope) is subjected to numerous wedge failure due to intersection of J1xJ6, J3xJ6, J3xJ7, J3xJ5, J2XJ5, J4xJ5, J4xJ6 and J4xJ7. The cut slope is also prone to planar (slab) failure (rock slides) due to the daylighting J4 and J5 joint sets. Combinations of these rock wedges and rock-slabs (e.g. Plates 6, 7, 8), explain the excessive development of overbreak in the left wall of the Spillway.

Plate 6. Intersection of bedding plane and subvertical joint give rise to wedge overbreak in the Spillway wall.-

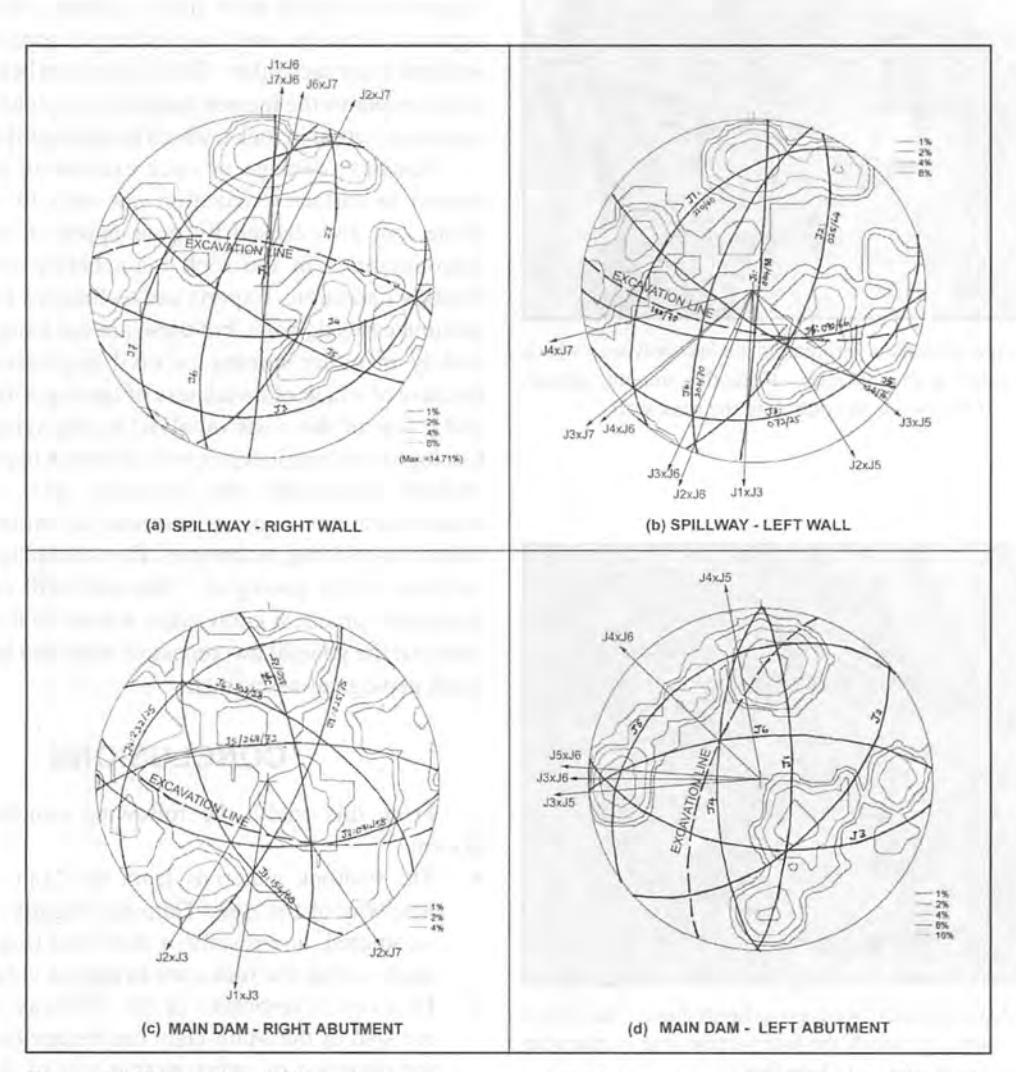
Excessive overbreak was also evident in the Main Dam, notably below the toe slabs in both left and right abutments of the Main Dam (e.g. Plate 4b). To assess the influence of geological structures on the formation of these overbreaks, kinematics stability analyses were carried out on the discontinuity data. Results of analyses for the left abutment and right abutment are shown in Figure 4c and Figure 4d, respectively.

Figure 4. Kinematic stability analyses to assess the mode of rock mass breakage at the Main Dam and Spillway foundations.

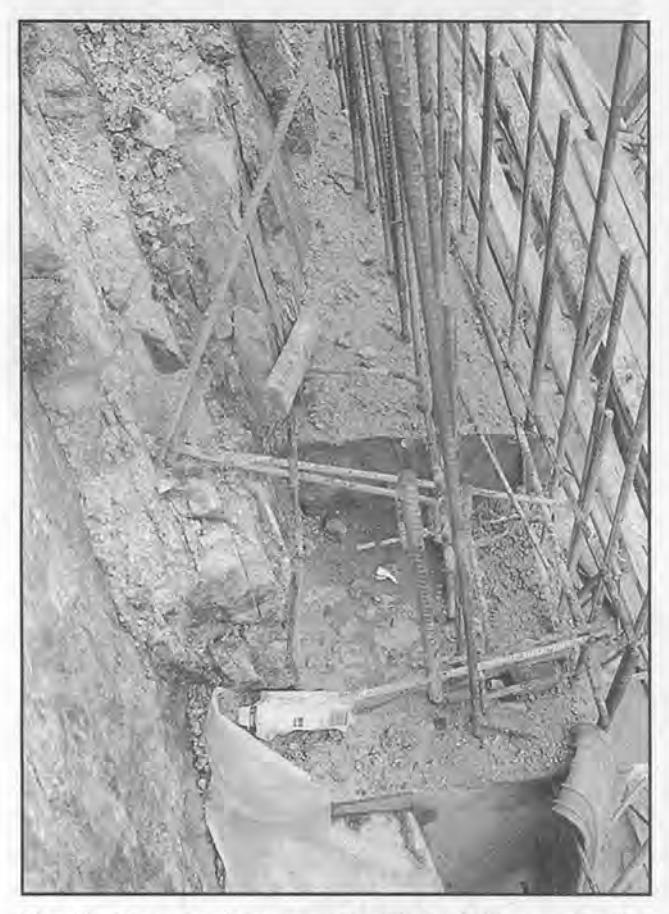
Plate 7. Example of planar overbreak in the Spillway wall which has been backfilled with concrete. Note the smooth, planar, subvertical joint surfaces which controlled the rock wall.

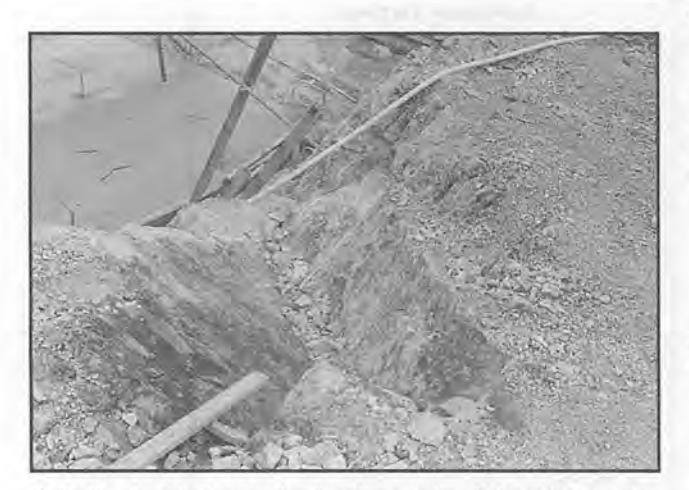
Plate 8. A typical example of wedge overbreak due to intersection of two sets of joints, in which the intersection line is plunging towards the excavation line (cut slope face).
