# Landslides in weathered granitic rocks in Japan and Malaysia

**Abstract:** Landslides in weathered granitic rocks are strongly affected by the types of weathering, which is site specific and quite different between temperate Japan and tropical Malaysia. Major landslide hazards induced by rainstorms in Japan and Malaysia are compared in terms of weathering scheme and landslide mechanisms. Many landslides have been induced in weathered granitic rock areas by rainstorms in Japan, killing nearly 1500 people since 1938. Some major landslides in Malaysia are also associated with weathered granitic terrain and these have killed more than 200 people.

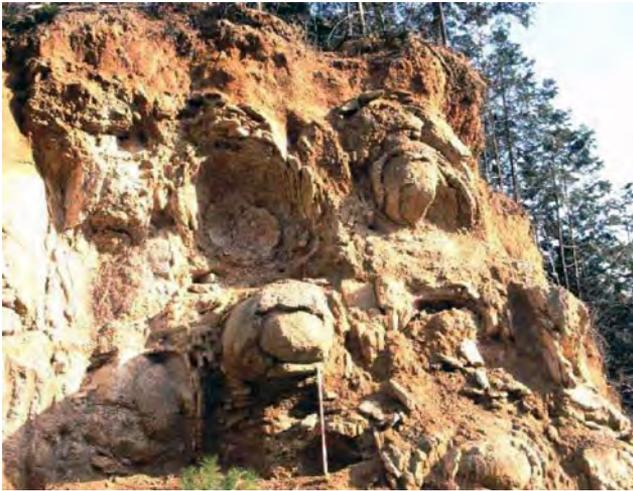
**Figure 3:** Spheroidal weathering of granite. Yagyu in Japan. The scale is 1 m.

A typical weathering profile of granite in subtropical climate consists of decomposed granite with core stones in the lower part and saprolite in the upper part (Ruxton & Berry, 1957). The core stones are formed by spheroidal weathering (Figure 3, Ollier, 1967). If decomposed granite is removed from core stones, tors are left (Linton, 1955). Another type of weathering profile, which is not as commonly

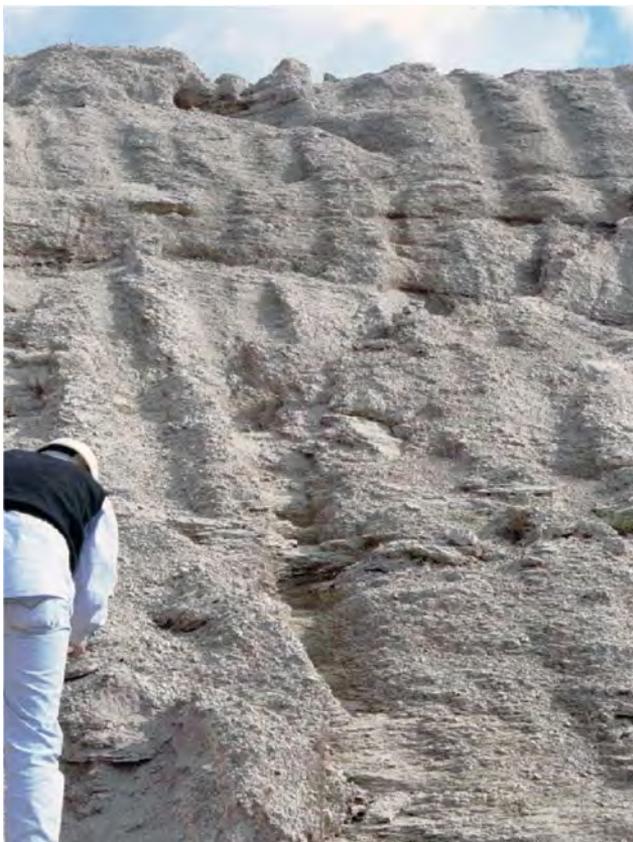
**Figure 4:** Micro-sheeting of granite. Hiroshima in Japan.

seen as that above, consists of saprolite in the upper part and a zone of micro-sheeting in the lower part (Figure 4, Hashikawa & Miyahara, 1977; Hashikawa, 1978; Folk & Patton, 1982; Chigira, 2001). Micro-sheets, previously called laminations (Twidale, 1971), are thought to be made by buttressed expansion due to unloading or a number of other factors (Folk & Patton, 1982). Weathering intensity has been classified from A to D (A, B, Ch, Cm, Cl, D) Japan and from I to VI in United Kingdom and Malaysia. Weathering grades D corresponds to IV and V and the weathered granite in these grades and soil are the materials

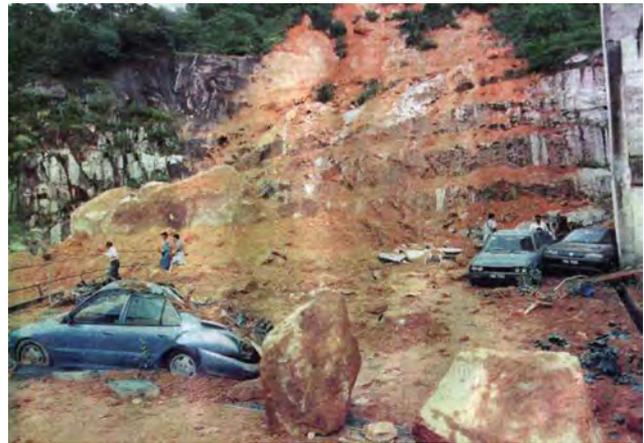
**Figure 9:** Landslide in Paya Terubong, Penang Island occurred in highly weathered to completely weathered granitic rock.

A major part of Penang Island is underlain by granite bedrock. Numerous small to medium-sized landslides have occurred in granitic terrains and this has been a major issue in the development of Penang Island, especially with respect to high-rise and residential buildings. Paya Terubong is located at the southeastern half of the Penang Island where the terrain is composed of medium-grained to coarse-grained biotite granite with microcline. (Ahmad *et al.*, 2006). The Paya Terubong landslide, which occurred in the 28<sup>th</sup> November 1998, is an example of the landslides that have occurred here (Figure 9). Fortunately there was no casualty, only 16 vehicles were buried and badly damaged. The average thickness of the highly to completely weathered granitic soil was found to be about 30 m. The sampled residual soil consisted of about 14% gravel, 55% sand, 18% silt and 13% clay; representing coarse-grained residual soil with high permeability that is susceptible to landslides.
