Utilization of drone-based photogrammetry for feasibility analysis of potential relocation area in Maleber District, Kuningan Regency, West Java

Center of Volcanology and Geological Hazard Mitigation, Geological Agency,
Ministry of Energy and Mineral Resources, Indonesia

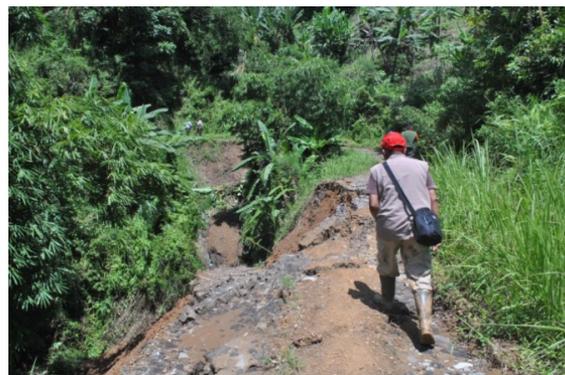
Figure 1: One of the landslide scarps at the main access to Cigerut Wetan and Cigerut Kulon.

Heavy rainfall during February 2018 in Kuningan Regency and surroundings areas triggered mass movement events in a number of regions. One of the worst affected areas is the main access to Cigerut Wetan Hamlet and Cigerut Kulon Hamlet, Cipakem Village, Maleber District, Kuningan Regency, West Java. There are four main scarps with several minor scarps alongside the road to both hamlets, as shown in Figure 1 (Lutfi *et al.*, 2018). Residents have been isolated as this road is the only access to the hamlets.

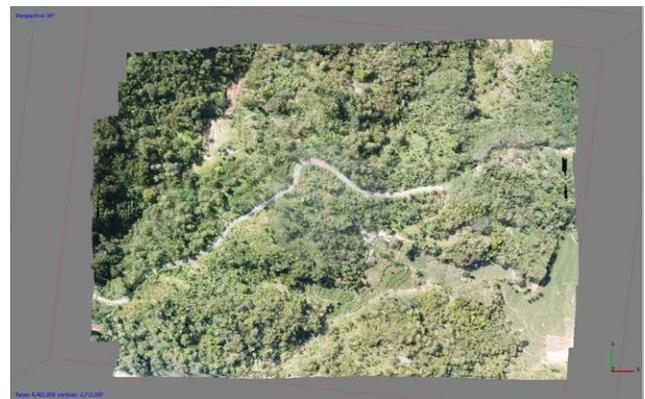
Figure 4: Georeferenced raster image for advanced spatial analysis.

The DEM is the data used for creating the Orthophoto model of Cikaso Block. It is saved as a georeferenced raster image for further analysis in ArcGIS (Figure 4) or even in Google Earth application. By overlapping it with Google Earth image, we can see how the block's condition from time to time has changed, making it possible to identify land conversion and paleo-landslides around the potential relocation area.

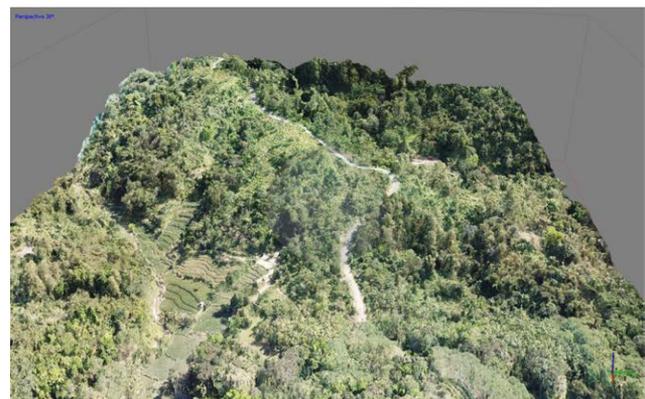
Figure 5: 3-D model of area of interest for geomorphological analysis.

The Cikaso Block is mostly covered by thick trees, which makes the topography difficult to desire in the DEM that resulted from photogrammetrical. Elevational contour from the Topographical Map of Lebakwangi Sheet 1308-533 (Bakosurtanal, 2000) are added to reflect the geomorphology of Cikaso Block and surroundings areas clearly. In Agisoft Photoscan, we can also see a 3-D view from Cikaso Block as shown in Figure 5.

southwest-northeast ridge on an undulating hill region. The top of the ridge has a 10° average slope while at the edge it has more than 50°. Intermittent springs from the bottom of this curving slope fills the V-shape valley in Cikaso Block as a part of Cisrigading tributary.

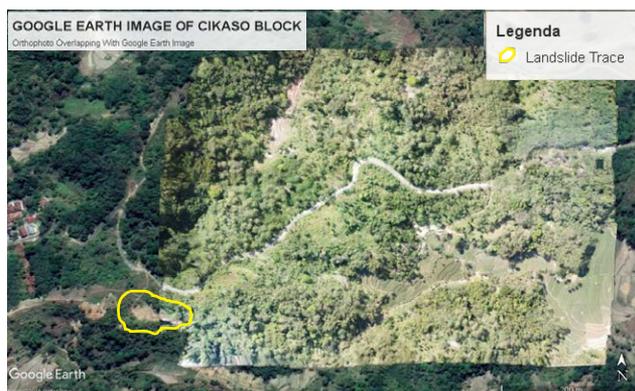
Figure 6: Overlapping photogrammetry image and Google Earth image has revealed the trace of an old landslide around the area of interest.

Additional imagery from the Google Earth image was looked of for a wider image. From this imagery a scarp was clearly visible on the southeastern part of the ridge or western side of the potential relocation area, outside the orthophoto boundary (Figure 6). By browsing the Google Earth historical image, we conclude that this landslide occurred around 2016. This evidence indicates that mass movement on this ridge have taken place in the past.
