Kinematic and limit equilibrium analyses of rock slope along Lebuhraya Pantai Timur 1 (LPT1) from km 90 to km 149

NUR ANATI BINTI AZMI*, ZAINUDDIN BIN MD YUSOFF

Civil Engineering Department, Faculty of Engineering, Universiti Putra Malaysia, 43400, Serdang, Selangor, Malaysia

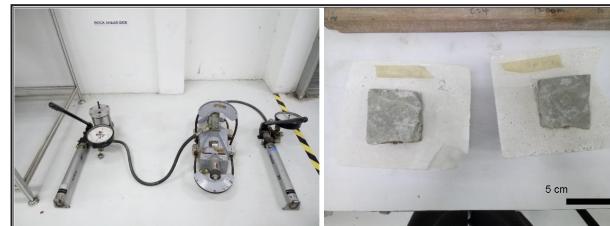
Figure 4: (a) Rock shear box apparatus (b) Sample in a mould for shear box testing.

The direct shear test (ASTM International, 2021) is used to determine the shear strength of rock specimens, particularly along discontinuities or fractures (Figure 4). This test provides valuable data for assessing slope stability, foundation behaviour, and the shear resistance of rock masses. It measures the cohesion (c) and the angle of internal friction (ϕ) of the rock specimen or discontinuity surface.

A normal load is first applied vertically to simulate in situ stress conditions. Then, a horizontal shear force is

gradually applied to the upper half of the shear box while the lower half remains stationary. This force is increased until the rock specimen fails along the discontinuity or until a specific displacement is reached. The normal load, shear force, and horizontal displacement are recorded throughout the test. The test is often repeated at different normal stress levels, and the results are analysed by plotting shear stress against normal stress. The cohesion and angle of internal friction are then determined using the Mohr-Coulomb failure criterion (Deere & Miller, 1966).

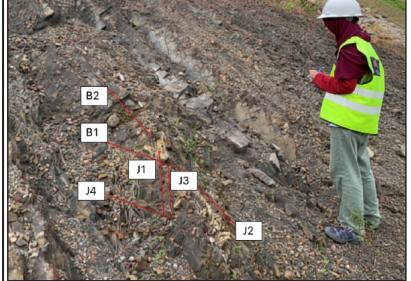
km 115	Shale	55/112	55/206(B1) 57/266(B2) 51/293(J1) 77/57(J2) 76/297(J3) 53/58(J4)	Wedge and toppling
