Landslides in weathered granitic rocks in Japan and Malaysia

Abstract: Landslides in weathered granitic rocks are strongly affected by the types of weathering, which is site specific and quite different between temperate Japan and tropical Malaysia. Major landslide hazards induced by rainstorms in Japan and Malaysia are compared in terms of weathering scheme and landslide mechanisms. Many landslides have been induced in weathered granitic rock areas by rainstorms in Japan, killing nearly 1500 people since 1938. Some major landslides in Malaysia are also associated with weathered granitic terrain and these have killed more than 200 people.

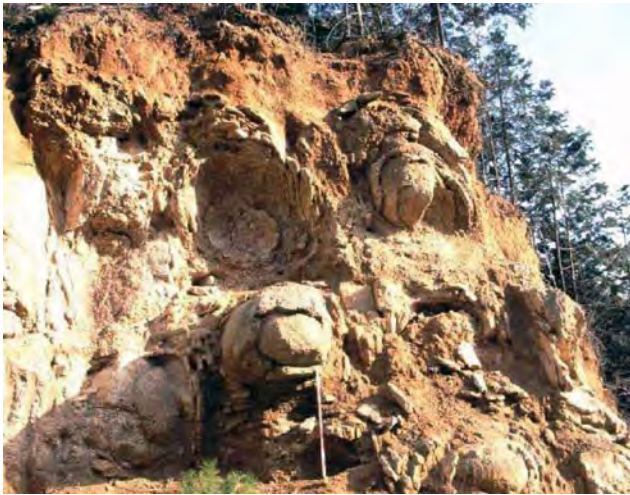
Figure 3: Spheroidal weathering of granite. Yagyu in Japan. The scale is 1 m.

A typical weathering profile of granite in subtropical climate consists of decomposed granite with core stones in the lower part and saprolite in the upper part (Ruxton & Berry, 1957). The core stones are formed by spheroidal weathering (Figure 3, Ollier, 1967). If decomposed granite is removed from core stones, tors are left (Linton, 1955). Another type of weathering profile, which is not as commonly

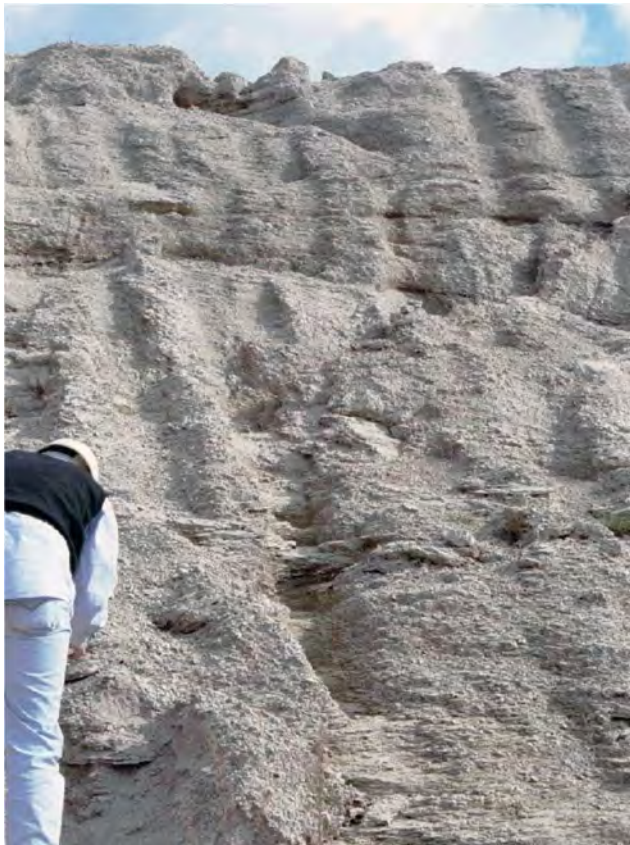
Figure 4: Micro-sheeting of granite. Hiroshima in Japan.

seen as that above, consists of saprolite in the upper part and a zone of micro-sheeting in the lower part (Figure 4, Hashikawa & Miyahara, 1977; Hashikawa, 1978; Folk & Patton, 1982; Chigira, 2001). Micro-sheets, previously called laminations (Twidale, 1971), are thought to be made by buttressed expansion due to unloading or a number of other factors (Folk & Patton, 1982). Weathering intensity has been classified from A to D (A, B, Ch, Cm, Cl, D) Japan and from I to VI in United Kingdom and Malaysia. Weathering grades D corresponds to IV and V and the weathered granite in these grades and soil are the materials

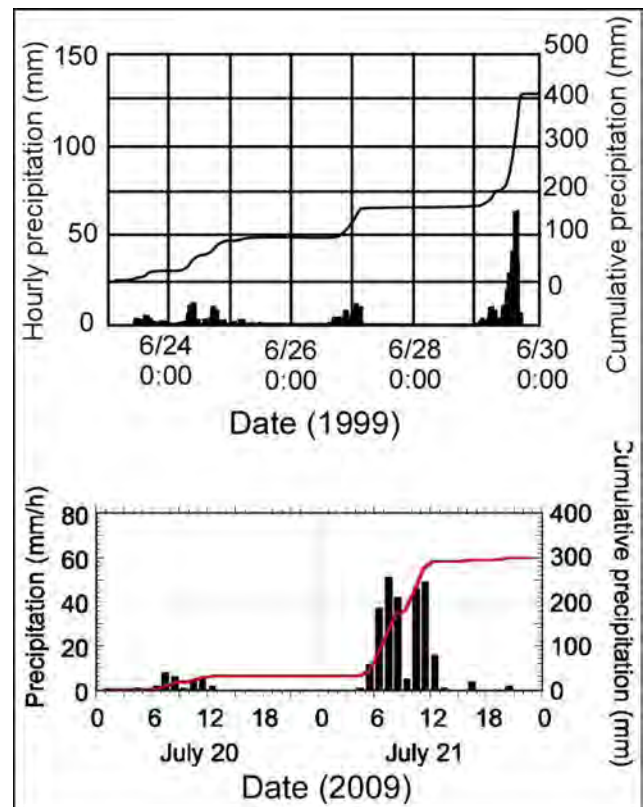
Figure 6: Precipitation during the rainstorm in Hiroshima in 1999 (upper) and in Yamaguchi in 2009 (lower).

Rainstorms induced many shallow landslides in weathered granite areas in Hiroshima in 1999 and in Yamaguchi in 2009. Precipitations of these were 250 mm and 300 mm per day (Figure 6), respectively. Landslides in Hiroshima took place in dense patterns within an elongate zone with a long axis trending NE-SW, which coincided with the zone of heavy rain of 50-70 mm/hr (Kaibori *et al.*, 1999). The individual landslides were relatively small, with lengths and widths of about 10-50 m and depths of only a few meters. The landslide density reached about 24 in an area of 1 km². Debris generated by a shallow landslide rushed down streams for a distance of as much as 1 km and struck residential houses in many locations. There were several types of landslides, and the most prevailing one was landslide of decomposed granite or debris on micro-sheeted granite. Micro-sheeting results in slopes of unstable structure, which, combined with mechanical disintegration of micro-sheets, leads to landsliding, as shown schematically in Figure 7. Landslides in Yamaguchi in 2009 occurred only in weathered granite areas and not in the surrounding metamorphic rocks. The granite is very similar to that in Hiroshima and is micro-sheeted.

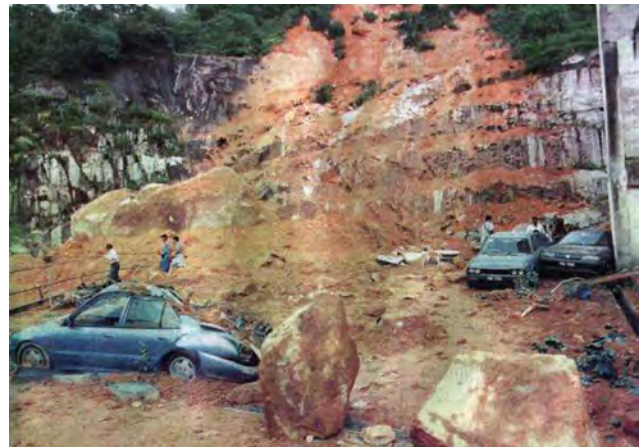
Figure 9: Landslide in Paya Terubong, Penang Island occurred in highly weathered to completely weathered granitic rock.

A major part of Penang Island is underlain by granite bedrock. Numerous small to medium-sized landslides have occurred in granitic terrains and this has been a major issue in the development of Penang Island, especially with respect to high-rise and residential buildings. Paya Terubong is located at the southeastern half of the Penang Island where the terrain is composed of medium-grained to coarse-grained biotite granite with microcline. (Ahmad *et al.*, 2006). The Paya Terubong landslide, which occurred in the 28th November 1998, is an example of the landslides that have occurred here (Figure 9). Fortunately there was no casualty, only 16 vehicles were buried and badly damaged. The average thickness of the highly to completely weathered granitic soil was found to be about 30 m. The sampled residual soil consisted of about 14% gravel, 55% sand, 18% silt and 13% clay; representing coarse-grained residual soil with high permeability that is susceptible to landslides.
