Landslide mapping and characterization for agriculturally intensive mountainous region of Cameron Highlands, Malaysia

Abstract: Relatively cool tropical climate with high annual rainfall experienced in mountainous tropical region creates favorable agricultural areas where intensive agricultural practices often correlate with increasing landslide events. While it has long been associated with landslides, agricultural practice in such areas especially in Cameron Highlands, Malaysia continues to flourish with minimal regard to environmental sustainability and safety. Therefore, this study aims to confirm the relationship between human activities and landslide occurrences and identify human practices that directly or indirectly cause landslides. Aerial photograph was used to identify landslides and anthropogenic features while other remotely sensed data including Interferometric Synthetic Aperture Radar (IFSAR) were used to establish the geomorphology of study area. A total of 207 landslides were identified in a 25 km² area from remote sensing study and field mapping. They were superimposed over several potential contributing factors including geology, slope gradient and human activit

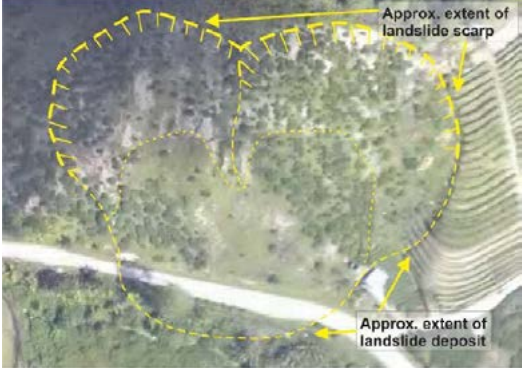
Type of movement	Materials	Description	Example with Simplified Sketch
Slide	Earth (Grade IV-VI material, usually consists of sand, silt and clay)	Usually rotational, occurring in soil, with speed ranging from fast to slow.

Most identified landslides within the study area can be classified as earth slide, while some developed into flow or flow-slide. Table 4 shows identified landslide type within the study area in Cameron Highlands. Slide type is the most common type, often occurring in weathered soil (Grade IV-VI) while several occurrences were also identified within recent deposits (colluvium). An overwhelming majority of landslides (74.40%) were characterized by rotational

slide, formed by sliding over a curved failure plane. This is a common failure type, where sliding occurs in almost homogenous materials, often composed of entirely soil material and not influenced by structural geology. 11.11% of observed cases were classified as translational slides, where earth mass simply breaks off the slope and slide along a planar failure plane. This type of failure can be found in very steep slopes where structural geology especially discontinuities plays a role in influencing the failure.

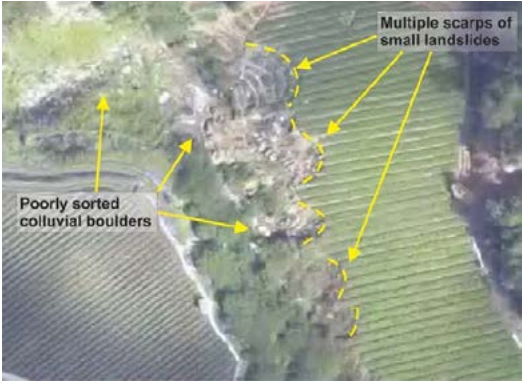
Colluvium (Poorly consolidated mixture of soil and boulder-sized rocks)	Usually rotational, occurring in gentler colluvial deposit

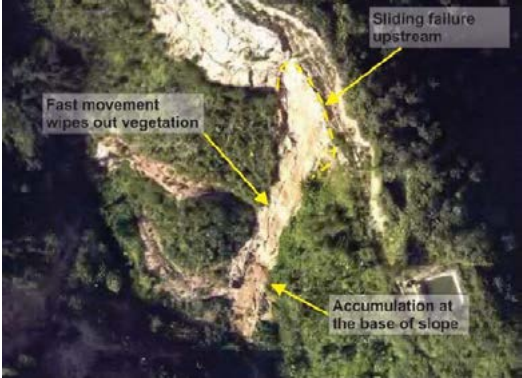
Flow-slide	Earth (Grade IV-VI material, usually consists of sand, silt and clay)	Triggered by landslide upstream, steep topography and heavy rainfall forms it into a flow.

Flow-slides are also common, attributed to steep topographic profile and heavy rainfall often received in the region – making any sliding failure upstream transforms into more fluid flow. They are characterized as very rapid flow of water-saturated granular material on slopes. The landslide deposits are often found at the toe of slope, up to 20 m away from source. Flow-slide accounts for 11.59% of total landslides.

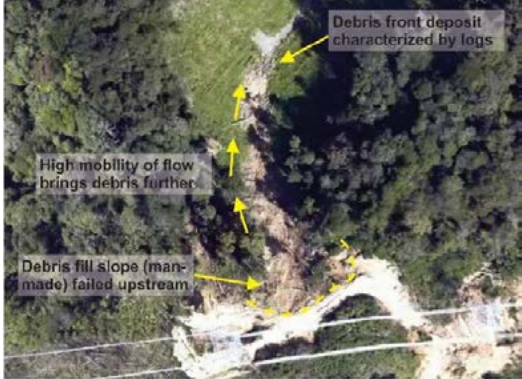
Flow	Debris (Mix of boulders, soil, trees, and anthropogenic materials)	Triggered by landslide, or poorly engineered slopes upstream, powered by surge of water during heavy rainfall.

Flow movement is defined as an extremely rapid surging flow of saturated landslide material in a steep channel (Hung *et al.*, 2014). In the study area, traces of flow movements were observed but uncommon compared to the other types accounting for 1.93%. Another 0.97% of landslides were interpreted to possess complex movement type which involves a combination of more than one type of movement.

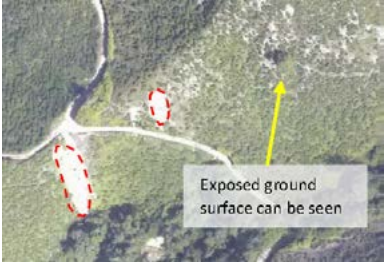
C a u s a l Factor	Influence contributing towards landslide	Associated agricultural practice	Example
Erosion	Erosion associated with surface water runoff and existing streams carve away portions of soil on slope, creating instability which leads to landslides.	-Sparsely vegetated farmland (relatively sparse compared to tropical rainforest cover)

<p>Exposed ground surface can be seen</p>
		-Fresh excavation for farming without soil cover / revegetation.

Erosion is identified as one of the major human-induced landslide causal factor. Erosion also led to other issues in Cameron Highlands, including silting up of river basins (Raj, 2002). This phenomenon is often observed in agricultural areas, lands cleared for major electricity lines, lands cleared for developments, and abandoned land clearance. Intense rainfall experienced in tropical climate increases surface runoff and exacerbated this issue. Efforts to protect earth surface must be made, especially revegetation of abandoned cleared lands to prevent continuous erosion.

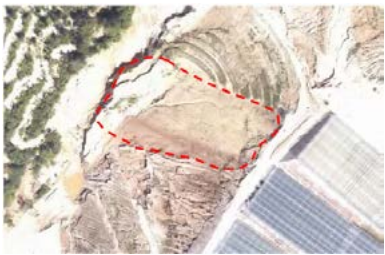
-Abandoned farmland without proper revegetation.

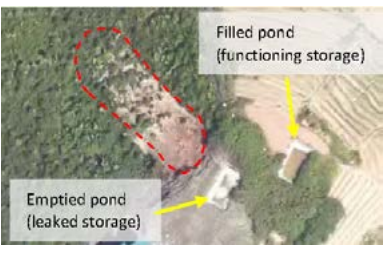
Poor drainage system	Poor drainage system especially in managing water collection system and outlet from irrigation runoff lead to water saturation in soil triggering landslides.	-Poorly maintained (leaking) water storage system.

<p>Filled pond (functioning storage)</p> <p>Emptied pond (leaked storage)</p>
		-Poorly managed water outlet from irrigation system.

Poor drainage system is another landslide-causing anthropogenic factor. They are often observed in agricultural areas where drainage systems were made without proper engineering design. This leave areas especially near water outlets and drainage leakages to be water-saturated and led to landslides. Poorly engineered slope re-profiling to create arable lands also led to landslide incidents. Overly-steep cut slopes and poorly compacted fill slopes (end-tipping) led to landslide events. These slopes are often poorly engineered without strengthening

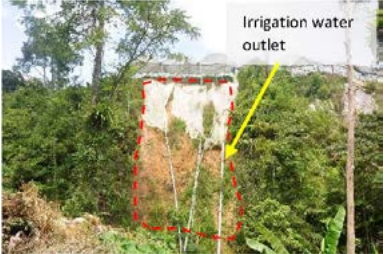
<p>Irrigation water outlet</p>

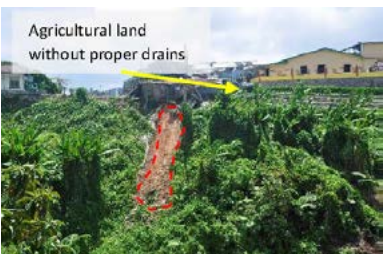
-Surface runoff from rain/ irrigation not managed in a systematic pipe/ drains.

<p>Agricultural land without proper drains</p>

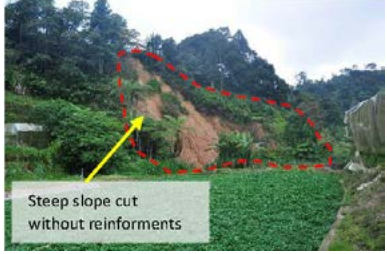
Slope re-profiling	To prepare the land for agricultural activities, original topography needs to be cut / filled. Such slope re-profiling activities without proper engineered approach often lead to failures	- Overly steep cut without any engineered slope reinforcements.

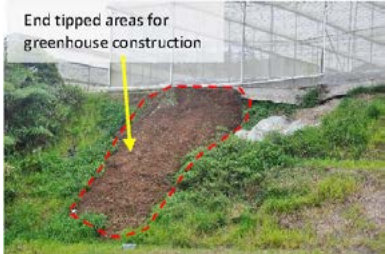
-End tipping (fill) without proper compaction / reinforcements

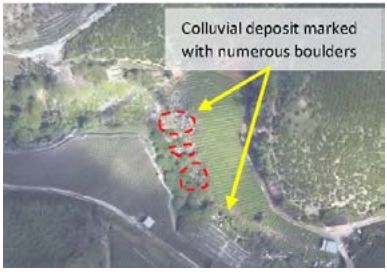
Adverse geological conditions	In certain areas, sensitive geological materials and relic landslides were turned into agricultural land, prompting fresh failures on site.	-Sensitive geological deposit (colluvium) turned into agricultural land

structures which are relatively expensive. Landslides were also recorded in agricultural areas developed in adverse geological conditions included colluvial deposit and relict landslides.

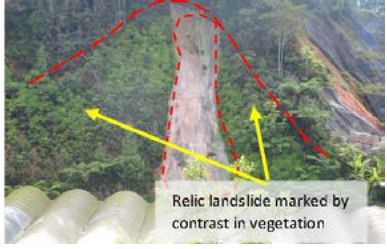
-Disturbance of relic landslides for agricultural purposes
