Influence of discontinuity on overbreaks and underbreaks in rock excavation — case study from Beris Dam, Kedah, Malaysia

TAJUL ANUAR JAMALUDDIN AND ISMAIL YUSOFF

Geology Department University of Malaya 50603 Kuala Lumpur

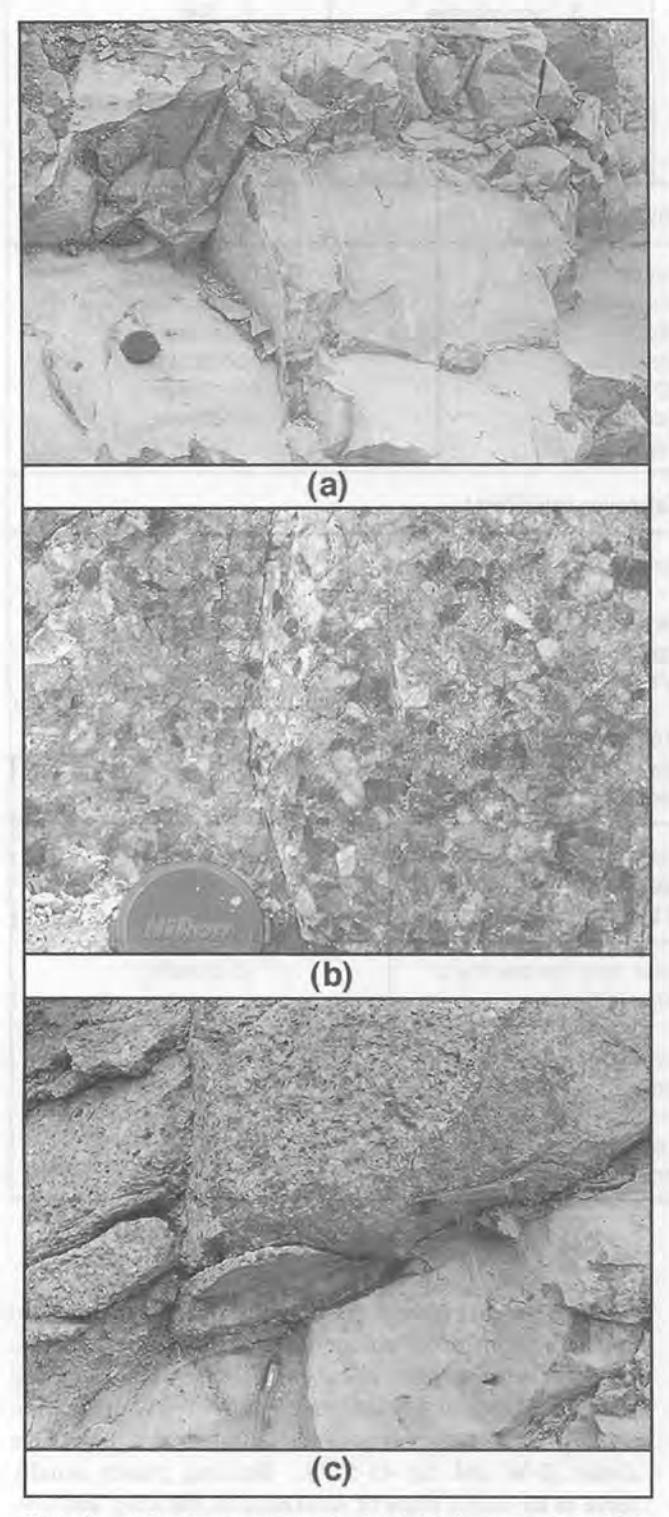
The Main Dam and the spillway are founded on a massive to thickly bedded sequence of conglomerate and gritstone, interbedded with some sandstone (Plate 1a, b and c). The rock sequence belongs to the Semanggol Formation of Triassic age (Ong, 1969; Burton, 1972). The conglomerate predominates at the right abutment hill and the main dam foundation. However, on the left abutment and the Spillway site, the conglomerate is interbedded with gritstone and coarse sandstone.

The matrix-supported, polymict conglomerate contains gravel to pebble-sized clasts of black to dark slate and mudstone, cert, quartz and other rock fragments (possibly volcaniclastics, sandstone and quartzite). The matrix is made up of coarse-sandy to gritty materials consisting of quartz, feldspar and rock fragments. The conglomerate, gritstone and the sandstone exposed at the foundation and left and right abutment of the Main Dam, as well as at the Spillway, vary from slightly weathered to moderately weathered (Grade II – III) rock. The rocks are generally hard, compact and well indurated. They are strong to very

Plate 1. a) Sandstone outcrop in the right abutment of the Main Dam. b) Close-up view of the slightly weathered, matrix-supported, polymict conglomerate at the Main Dam found. c) Slightly weathered sandstone-conglomerate interbed in the right abutment of the Main Dam.

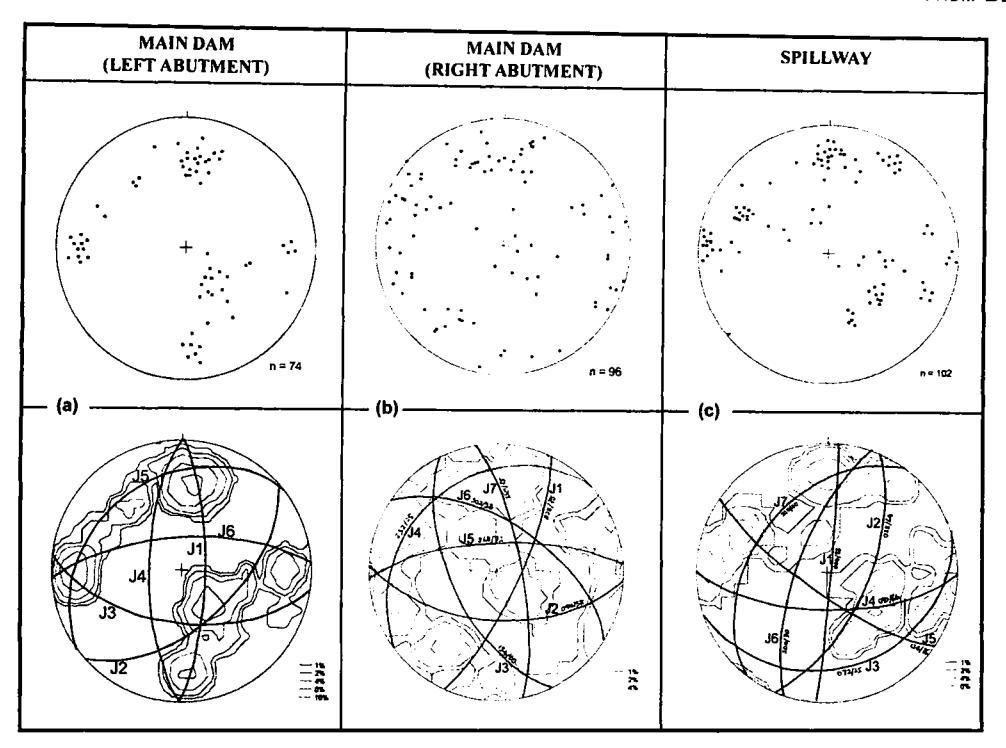
Discontinuity survey at the Main Dam site was divided into two sections; i.e. the Left Abutment and the Right Abutment. Stereographic projections of the discontinuities from the left and right Abutments of the Main Dam are shown in Figure 2a and 2b, respectively. Results indicated that the rock masses at the Main Dam site as a whole are dissected by at least 6 sets of discontinuities (e.g. Plate 2a and b).

Figure 2. Stereographic plot of discontinuity data from (a) Left Abutment, Main Dam, (b) Right Abutment, Main Dam, and (c) Spillway (right and left walls).

The rock mass in Spillway is also affected by intense jointing (e.g. Plate 4a and b). The joints are very closely spaced which resulted in inequidimensional, polygonal blocks of highly variable sizes from several cm to 0.8 m across. Stereographic projection of the discontinuity data (Fig. 2c) indicates that the discontinuities can be broadly grouped into 7 sets as summarised in Table 4.
