## **The slope stability problem at Mae Moh Lignite Mine, Lampang Province, Northern Thailand**

W. TANDICUL<sup>1</sup>, N. MUANGNOICHAROEN<sup>2</sup>, and N. GUMPERAYARNNONT<sup>3</sup>

<sup>1</sup>Lignite Mine Department, EGAT, Bangkok.

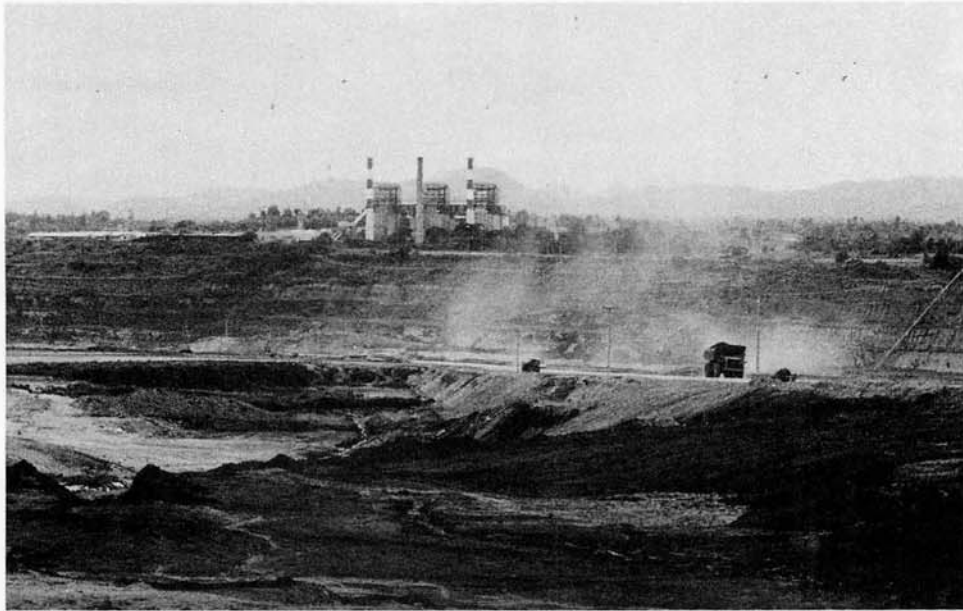
The mine pit started at a locality on the southeastern flank of the syncline and progressed down-dip to the northwest toward the central part of the basin, above which 3 operating power plants are located (Figure 3). At present, the rim of the pit is only 400 metres from these plants. As the mine progressed, pit slope failures occurred especially on the northwestern and southeastern slopes. The failure types were rock slides—circular and wedge failures and planar slides, topple rotational slumps, and debris flows.

Fig. 3. Mae Moh lignite mine, northwestern pit slope and 3 operating power generators.
