## Effects of Marikina Faults on groundwater

MAJEEED M. FAISAL, SHARIFF A.K. OMANG AND SANUDIN HJ. TAHIR

**Abstract:** Metro Manila faces a major shortage problem that will necessitate the development of all possible sources. Structural geological study is an effective tool in maximizing the exploration of water resources. The Marikina Faults, a permeable zone which could facilitate the movement and occurrence of groundwater should be fully evaluated for such purpose.

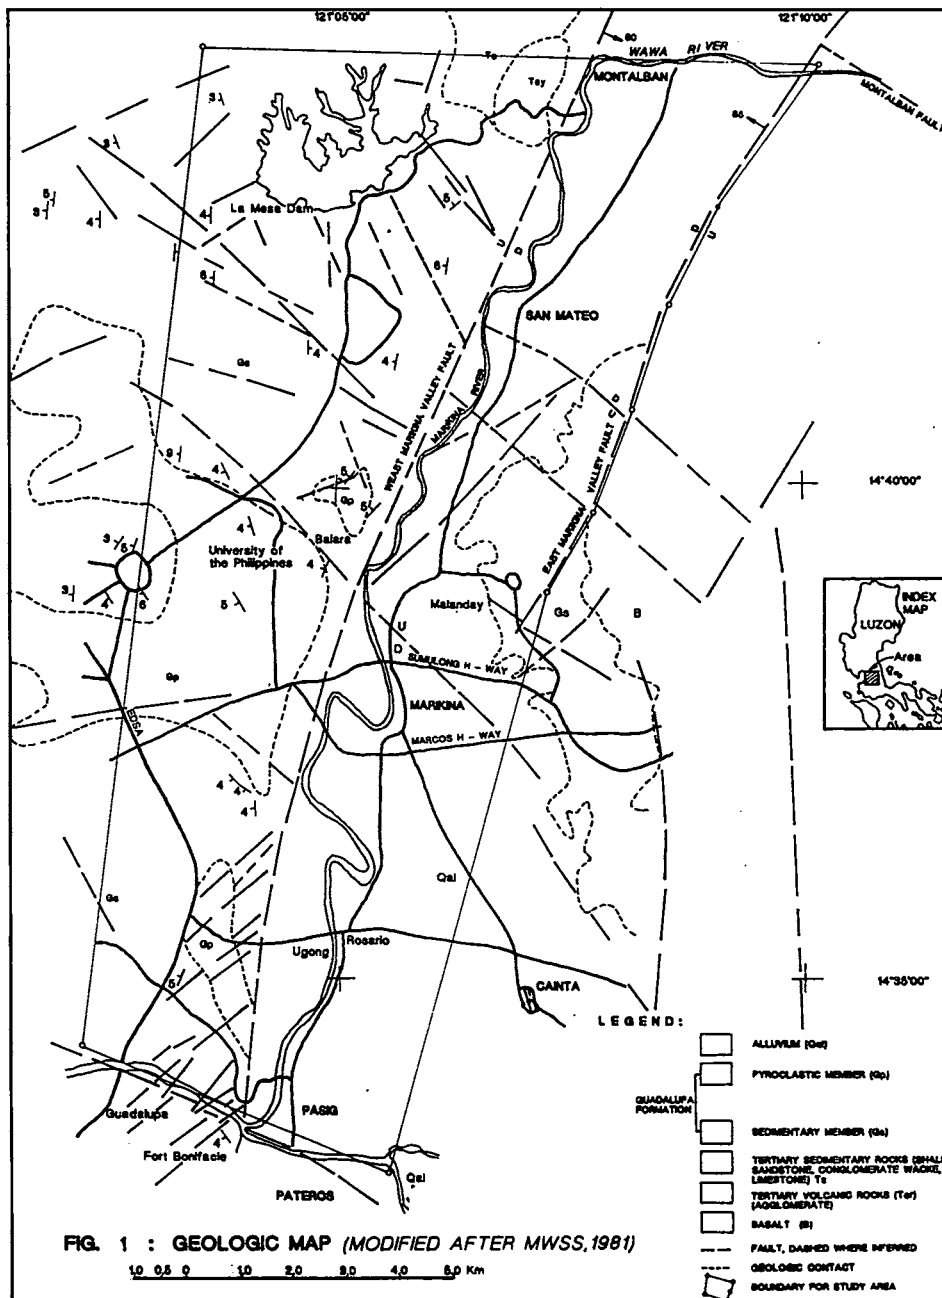
FIG. 1 : GEOLOGIC MAP (MODIFIED AFTER MWSS, 1981)

Figure 1. Location stratigraphic column.

Three lithologic units are present in the local mapping area. These units consist of the Upper Miocene Alagao Volcanics, Pleistocene Guadalupe Formation, and Quaternary Alluvium (Fig. 1). The Marikina Fault zone (Fig. 2), is a group of major geologic structures in the Greater Manila Area (GMA) which controls the morphology of the Marikina Valley and the course of the Marikina River from Montalban in the north to Pasig in the south. Several secondary faults or fracture systems can be observed traversing the main faults. In the mapped area (Fig. 3), the Marikina Fault zone consists of several parallel faults the most

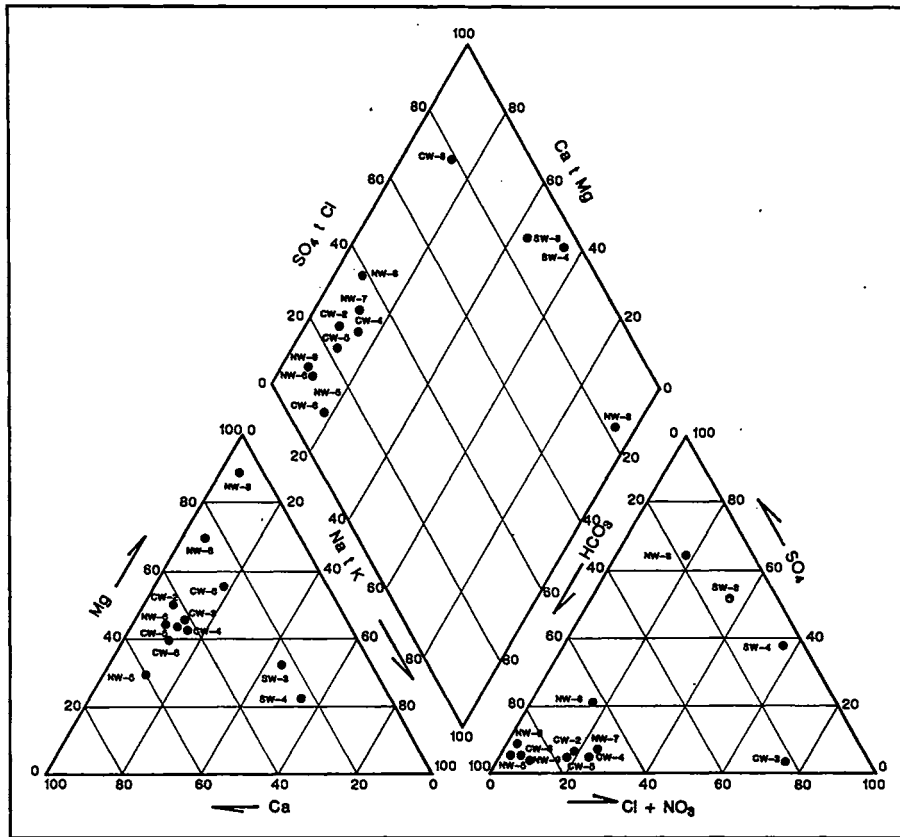
Figure 4. Chemical analysis of water from western block of WMVF wells plotted on a piper trilinear diagram.

Analytical results of groundwater samples (Figs. 4 and 5) also indicate marked chemical composition differences in the eastern and western blocks of the WMVF. The western fault block has relatively high iron, magnesium, nitrate and zinc concentrations while the eastern block is high in bicarbonate, chloride, sodium, potassium and calcium contents. These variations may be correlated to the differences in the underlying lithologies of the Guadalupe Formation and the Quaternary Alluvium in the western and eastern blocks, respectively. The contact of these lithologic units is fault-controlled. The high bicarbonate levels

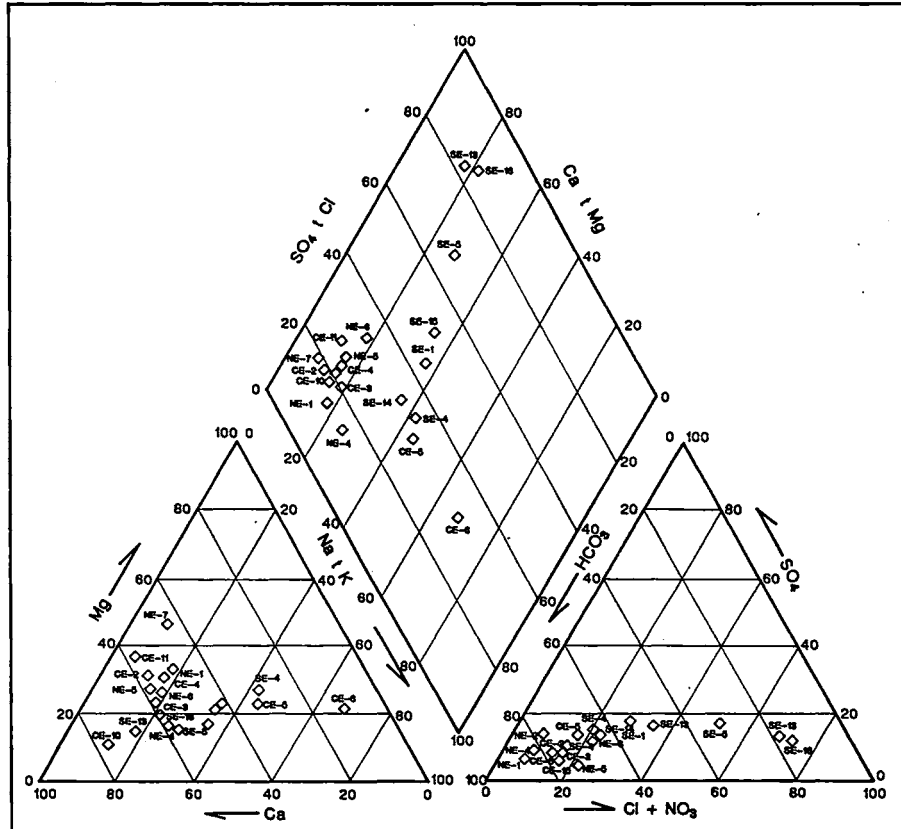
Figure 5. Chemical analysis of water from eastern block of WMVF wells plotted on a piper trilinear diagram.

within Quaternary Alluvium may also explained by its proximity to the recharge area in the east. The high sodium and chloride contents may have resulted from the periodical seawater admixture with the Pasig River waters during the normal tidal fluctuations and found its way within the alluvial deposits.
