# Engineering geology in Malaysia – some case studies

TAN BOON KONG

**Abstract:** Engineering geology deals with the application of geology to civil engineering and construction works. The fundamental input in engineering geology would involve, among other things, studies on the lithologies, geologic structures and weathering grades of the rock masses since together they determine the characteristics and behaviours of the rock masses. In addition, project-specific requirements and problems need to be addressed. This paper presents several case studies on Engineering Geology in Malaysia such as: Foundations in Limestone Bedrock, Limestone Cliff Stability, Rock Slope Stability, Dams, Tunnels, Riverbank Instability, Slope Failure due to Rapid Draw-down, Urban Geology & Hillside Development, and Airports. The various case studies presented here are based mainly on the author's ~35 years of past practice and experiences.

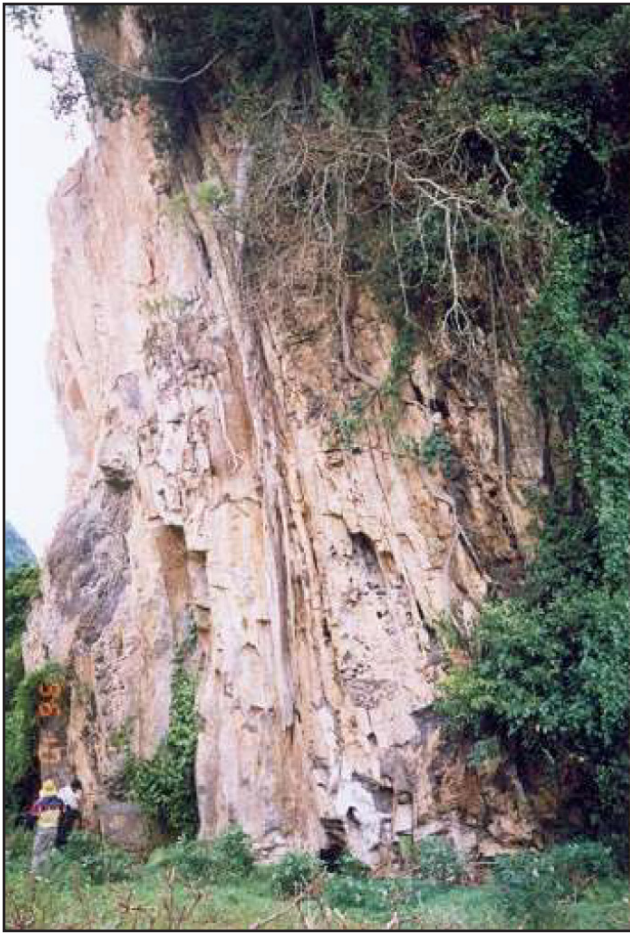
**Figure 7:** Sub-vertical bedding planes giving rise to rockfall, Tambun, Ipoh.

The engineering geology of limestone, covering both limestone hills and bedrock, with their associated problems such as rockfalls and sinkholes, cavities, slumped zone, etc. has been reviewed by the author in a previous paper, Tan (1999c). Further details can be referred to in the IEM-GSM forum proceedings on karst/limestone mentioned above. Of particular interest and reproduced here is the case study on the survey of limestone cliffs for urban development purposes in the Tambun (Ipoh) area. The limestone cliffs were surveyed for geological structures (fractures) and solution features, and were then assessed for their stability based on the combination of these features. Hazard maps were then produced to indicate various segments of the cliff faces with differing stability or degree of hazards. Figure 6 shows an example of the hazard map produced for some segments of the limestone cliffs. The results of the survey indicate that the stability of the various limestone cliffs was controlled by-and-large by the north-south trending bedding planes, e.g. Figure 7. More details on this case study are contained in Tan (1998b, 1998c).

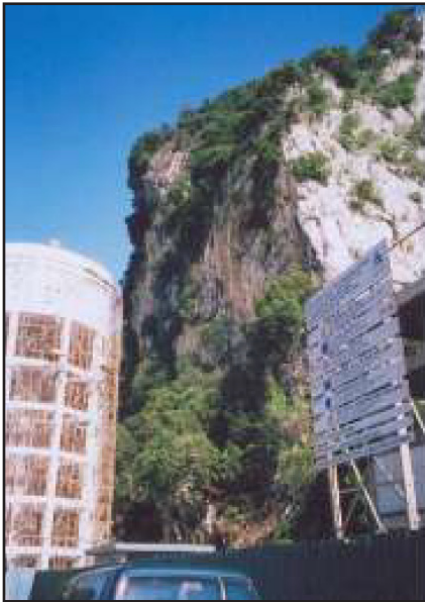
**Figure 8:** Water tank at Batu Caves limestone cliff, Kuala Lumpur.

Figure 8 shows a case study on the assessment of limestone cliff stability adjacent to a water tank site in Batu Caves, Kuala Lumpur, Tan (2005a). The stability of the limestone cliff is of great concern, and again, assessment is based on the combination of geologic structures and solution features present at the limestone cliff in question.

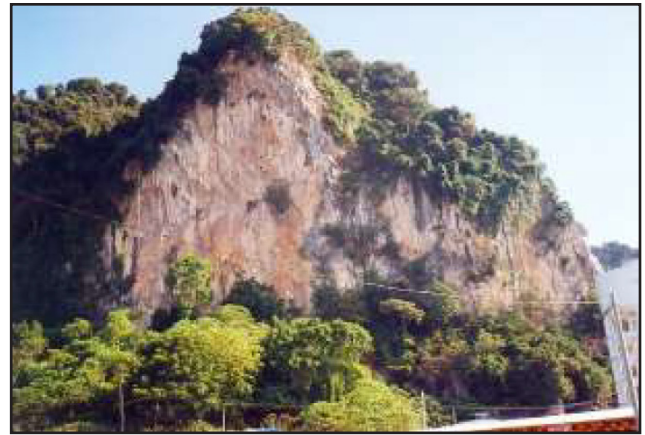
**Figure 9:** Overhanging limestone cliff adjacent to proposed condominium “A”, Batu Caves, Kuala Lumpur. Lower half of cliff has fallen previously, producing rockfall debris at the base of the cliff.

As it turned out, the limestone cliff in condominium “A” showed a major overhanging cliff, with evidence of previous rockfalls (rockfall debris) at the base of the cliff.

Figures 9 and 10 show the limestone cliffs concerned.

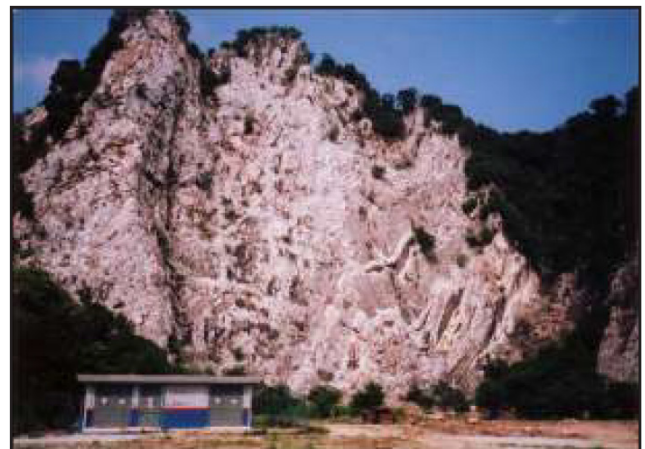
**Figure 10:** Limestone cliff adjacent to proposed Condominium “B”, Batu Caves, Kuala Lumpur. The cliff face is an ex-quarry face which has been blasted to  $< 90^\circ$ . Bedding planes can be seen on the lower right corner of the quarry face.

It was deemed unsuitable for development. In the case of condominium “B”, the adjacent limestone “cliff” was in fact an ex-quarry face, cut back to  $< 90^\circ$ . In addition, the original limestone beds which were initially overhanging, had also been cut back to  $< 90^\circ$ . Nearby limestone beds were also

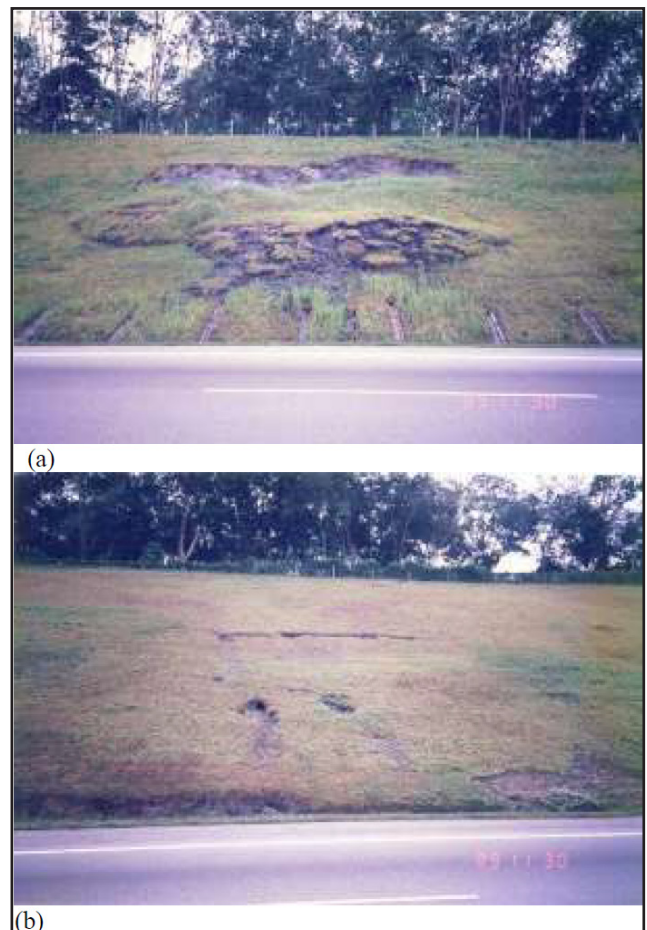
Figure 12a, 12b: Graphitic schist soil slope failures, Senawang-Ayer Keroh Highway.

Figures 12a-12b provide examples of graphitic schist soil slope failures along the Senawang - Air Keroh Highway. Route geology along the Senawang - Air Keroh Highway shows the predominance of graphitic schist towards the Air Keroh end of the highway. The survey results show that the majority of cut slope failures occurred in the graphitic schist material, indicating geological or material control in the failures. Figure 12c shows secondary minerals formed from the oxidation and hydrolysis of pyrite contained in the graphitic schist – these chemical reactions involving the pyrite cause weakening of the graphitic schist soils.

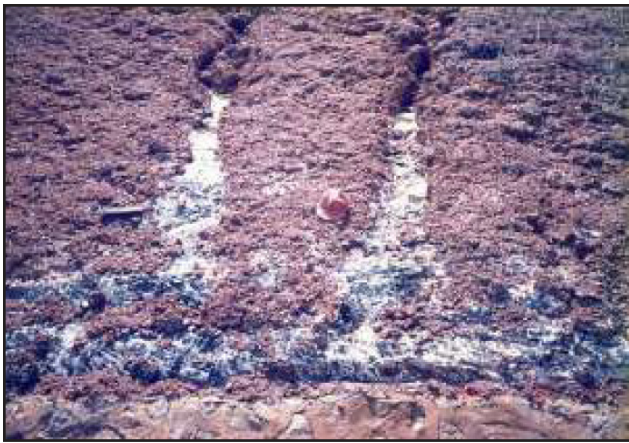
**Figure 12c:** Secondary minerals on graphitic schist, Senawang-Ayer Keroh Highway.

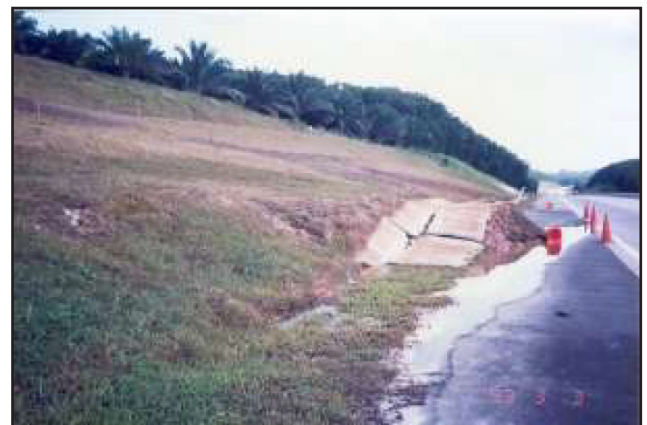
**Figure 14:** “Flattened” cut slope in graphitic schist, N-S Highway near Rawang.

Yet another major slope failure involving the graphitic schist soils occurred along the North-South Highway near Rawang - again, slope failure occurred repeatedly even after re-grading. The slope has since been practically “flattened”, Figure 14.

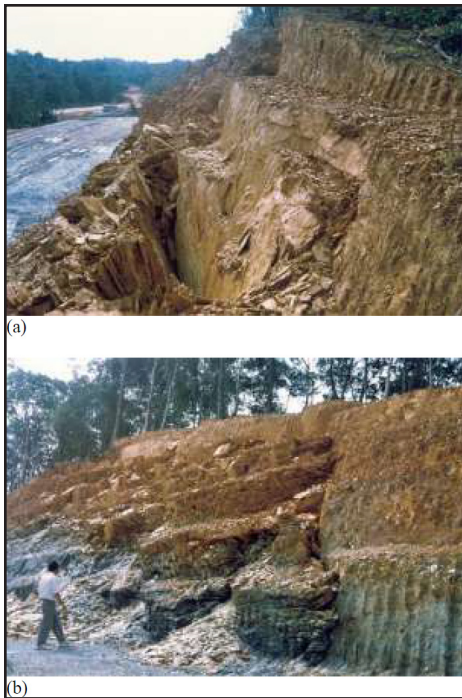
**Figure 15a, 15b:** Slope failures controlled by bedding planes and faults, Sarawak rural road.

In the case of a rural road in Sarawak, shale slopes are the problematic slopes compared to the sandstone slopes; in addition, structures such as bedding planes/foliations and faults, produce the major slope failures, Figures 15a-15b.

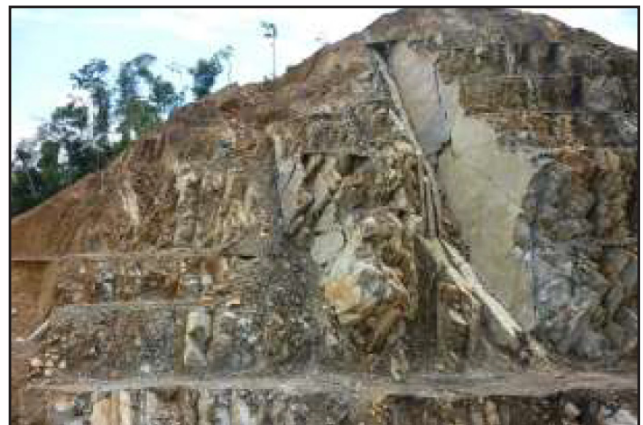
**Figure 17:** Major plane failures along bedding planes in sandstone of the Belaga Formation, Sarawak.

Figure 17 shows some major plane failures involving the sandstone beds of the Belaga Formation. Figure 18 shows ravelling and erosion of the carbonaceous shale which resulted in the slope failure. Further details can be referred to in the report by Tan (2013a).

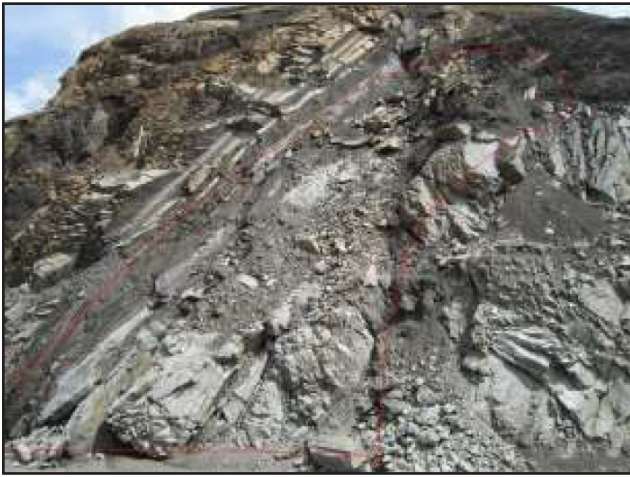
**Figure 18:** Failure in black carbonaceous shale due to ravelling and erosion, Belaga Formation, Sarawak.

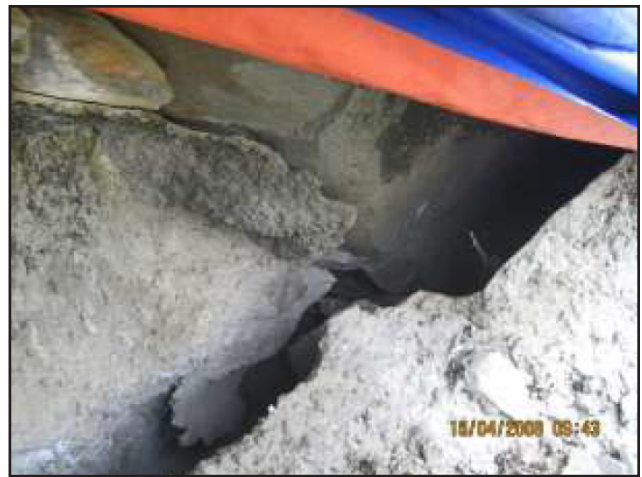
**Figure 19a:** Opening of sub-vertical joints in sandstone due to toppling failure, Bakun Dam, Sarawak.

Another case study of rock slope stability involves also the same Belaga Formation at the nearby Bakun Dam in Sarawak. Slightly downstream from the Bakun Dam, a major high rock slope suffers from a series of toppling failures due to a major set of sub-vertical joints that strike sub-parallel to the rock slope. The same set of joints can be traced from the base of the slope to the top of the slope, and as the joints open up, they form a series of potential toppling failures.

Figures 19a and 19b show some examples of these toppling failures.

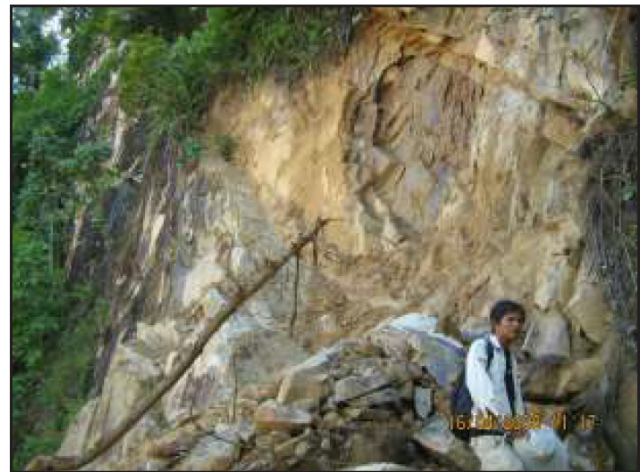
**Figure 19b:** Toppling failure due to sub-vertical joints in sandstone, Bakun Dam, Sarawak.

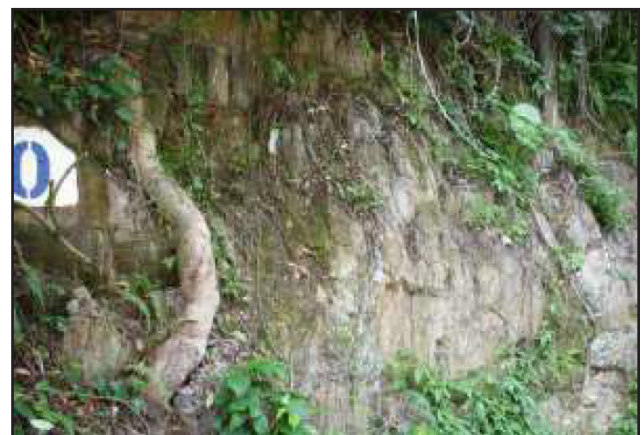
**Figure 20:** Root wedging along joints in quartzite of the Kenny Hill Formation, Kuala Lumpur.

the instability and potential rock falls involving the quartzite rock slope is caused by roots of large trees penetrating the joints in the quartzite rock, and wedging out the blocks or wedges of rock. This is a classic case of root wedging and destabilizing the rock slope, in contrast to plants/plant roots being used as reinforcing elements for stabilizing soil slopes. As remedial measures, the roots were dug out/killed off, and the large trees growing on top of the rock slope were all chopped down (much to the chagrin of the landscape guys), among other things.

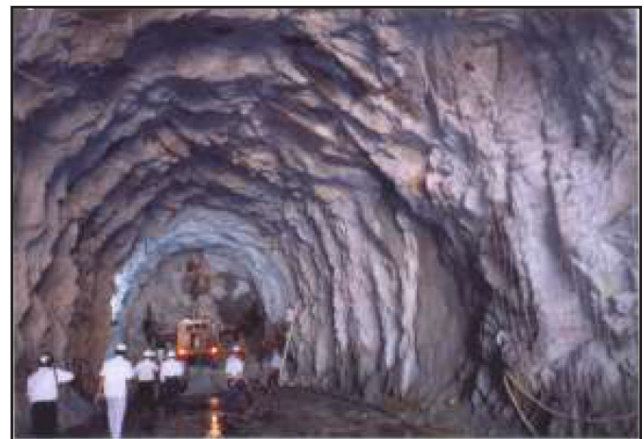
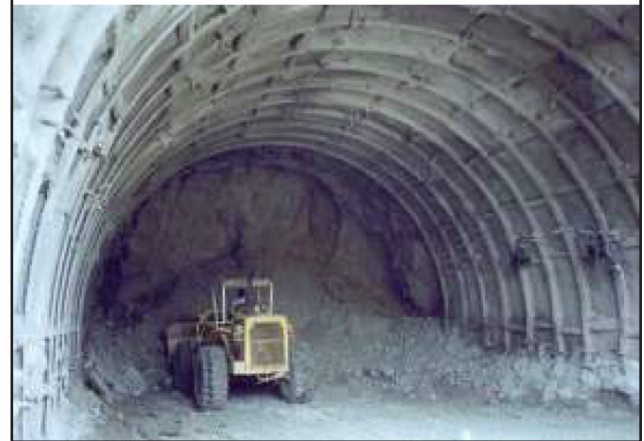
**Figure 21a, 21b:** Highly fractured granite and steel sets support, diversion tunnel, Sg. Selangor dam.

Figures 21a-21b show highly fractured granite and heavy steel sets support for the highly fractured and sheared granite in the diversion tunnel of the Sungai Selangor dam at Kuala Kubu Baru.

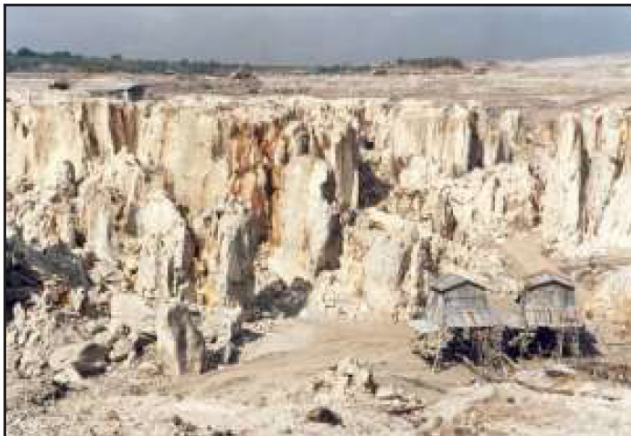
**Figure 22b:** Limestone pinnacles/bedrock exposed by previous alluvial tin mining, Sungai Way (now Bandar Sunway), Kuala Lumpur.

Figures 22a and 22b show some karstic limestone in the Kuala Lumpur area, exposed by previous tin mining and limestone quarrying works. It is not difficult to envision the difficulties associated with tunnelling in such ground conditions. The highly variable ground conditions within short distances (tunnel face varying from full face rock, mixed face rock-soft soil, to full face soft soil) would be the key, major factors affecting the TBM works.

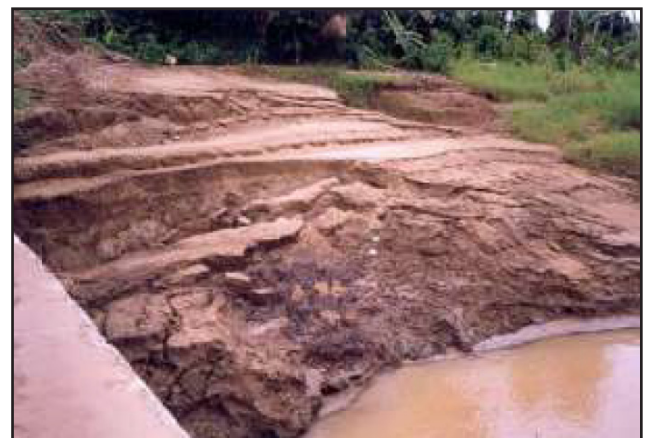
**Figure 23:** Riverbank instability, Sarawak.

Collapse of river bank is a natural phenomenon, part and parcel of the geological processes in the widening of rivers. Riverbank instability becomes a major concern for riverine townships or settlements built along major rivers, such as along the Batang Rajang (Rajang River) in Sarawak. Numerous major riverbank collapses affecting infrastructures in some of these riverine townships have been documented, Tan (2001). Figure 23 shows an example. The weak nature of the alluvial deposits constituting the riverbank slopes and rapid fluctuations (especially lowering) of water levels are some of the major causes for the slope failures.

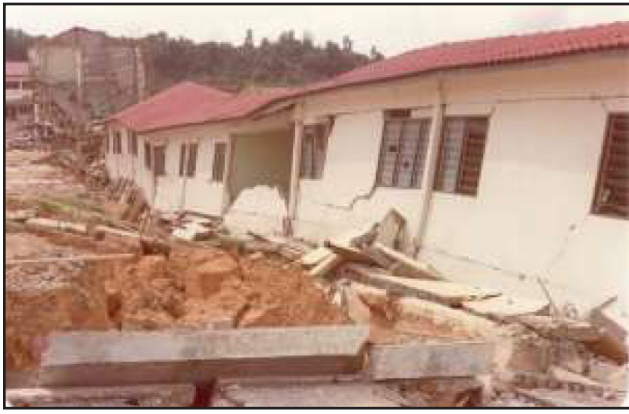
**Figure 24:** Rapid draw-down of mining pond triggering slope failure and destroying houses, Kuala Lumpur.

Rapid draw-down triggering slope failure is a well known phenomenon. A classic example is shown in Figure 24. The pumping of water in an ex-mining pond has triggered the drastic failure of the slope adjacent to the pond, destroying newly completed houses built on top of the slope.

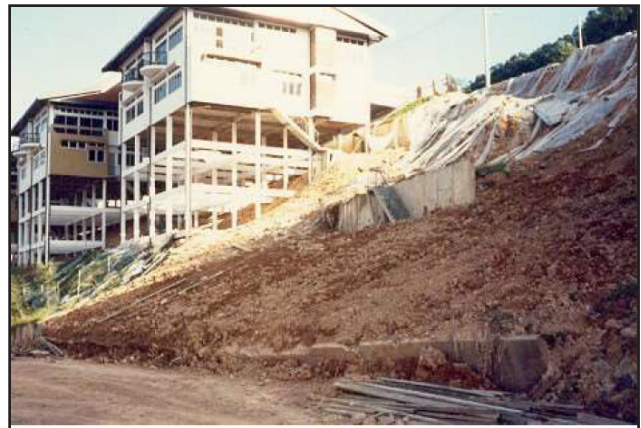
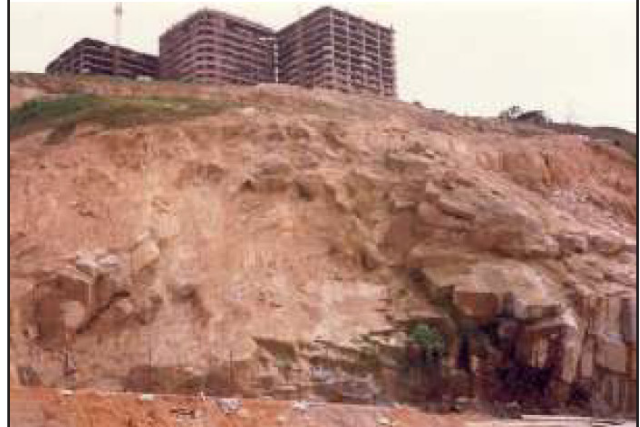
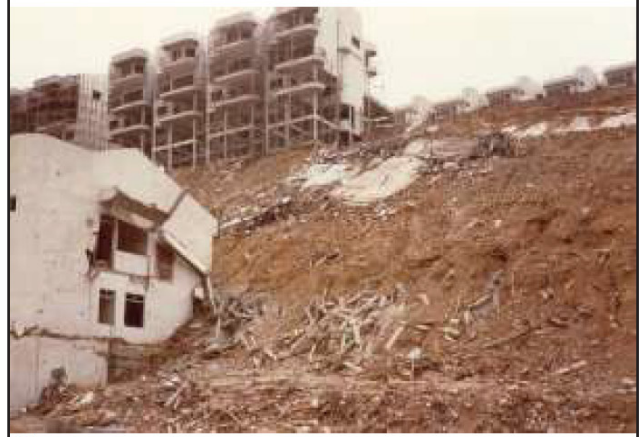
**Figure 25a-25c:** Slope failures associated with housing projects in hilly terrains, Kuala Lumpur.

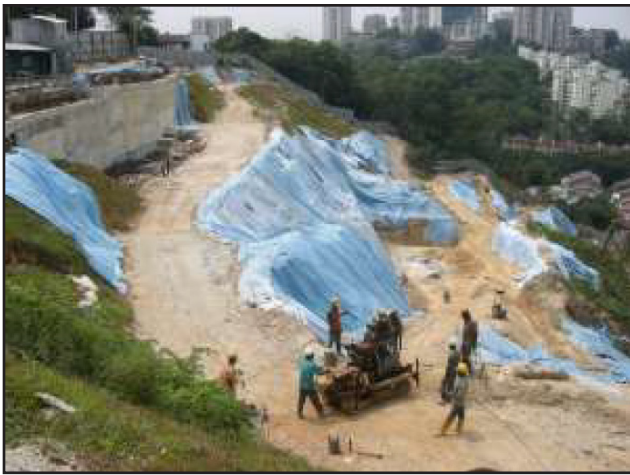
**Figure 26:** Housing development on slope underlain by the Kenny Hill Formation, comprising interbedded quartzite and phyllite, Kuala Lumpur.

Popularly known as the Damansara 21 project, this hillside development plans to build 21 units of high-end bungalows on a slope/sloping land. Preliminary works were carried out, including stabilization of the upper part of the slope with contiguous bored piles, etc. The site was located within the Kenny Hill Formation, with the rock strata mostly sub-horizontal in orientations, hence stable. A

Figure 26 shows the project site during the early stage of construction.

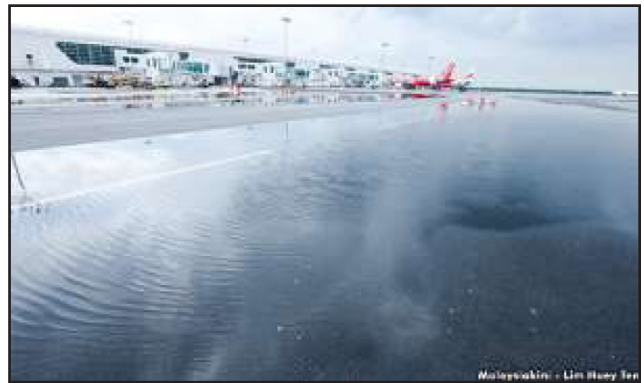
**Figure 28:** Ponding at KLIA2 – “Now everyone can swim” (from Malaysiakini, July 2015).

numerous construction problems and serious delays ensued, with some of the problems continuing post-construction (e.g. long term settlement of the underlying soft clays resulting in cracking of pavements, ponding/flooding after heavy rains, etc.). As the story goes, the initial site chosen for KLIA2 was north of the KLIA, where the underlying geology comprises residual soils and rocks of the Kenny Hill Formation, minus all that soft materials of the coastal deposits and all in all less problematic – so wither the “site selection”?

Figure 28, taken from a recent website posting, shows the continuous problem of serious ponding/flooding at KLIA2 – interesting enough, the heading for the photo was “Now everyone can swim”, a play on the slogan “Now everyone can fly” by a local, very successful airline.
