Land subsidence hazards in Hanoi, Vietnam

Abstract: The study area is located in the southwest of Hanoi, the capital of Vietnam, encompassing the districts of Quoc Oai, Chuong My, My Duc, and Ung Hoa. This region is densely populated and has experienced frequent collapses and land subsidence over the years. Notably, these phenomena have persisted into 2023. The foundation structures in the southwestern part of Hanoi are categorized into five types, with Quaternary sediments forming the upper layer and limestone constituting the base. The formation of Quaternary sediments over the Dong Giao Formation limestone is closely linked to the transgressive and regressive processes that occurred during the Quaternary period. Based on geological research, geophysical studies, and wellbore analysis, the authors have drawn the following conclusions: 1. The collapses are associated with underground karst activity, and 2. Urbanization and underground exploitation are key factors contributing to the increasing frequency of collapses. These research findings are scientifically significant and serve as a valuable resource for identifying and warning about geohazards in areas with similar geological

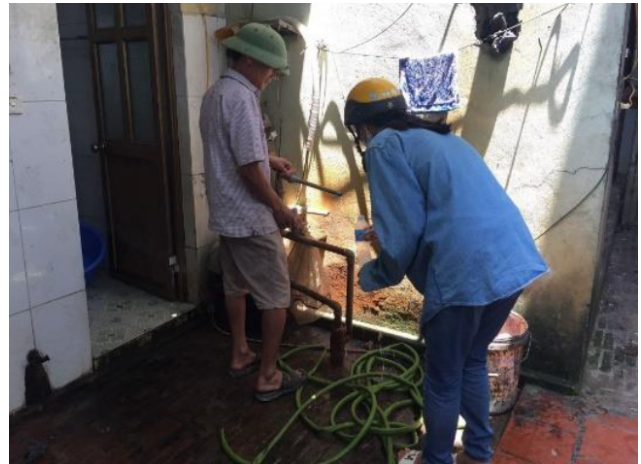
Figure 2: Survey of groundwater exploitation parameters.

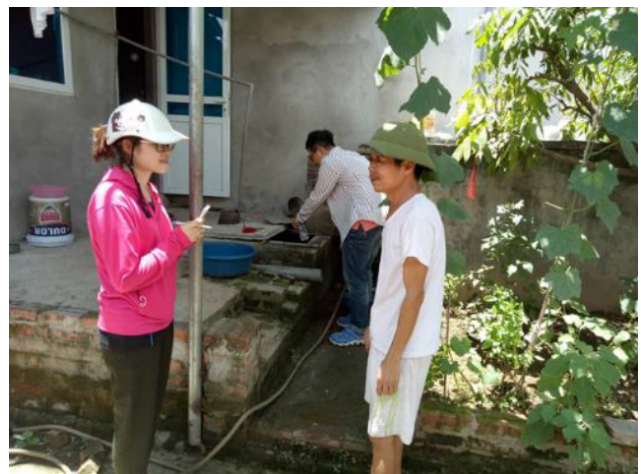
Figure 3: Survey and collect information at places where land subsidence occurred.

Survey and study of wells of surrounding people and areas where land subsidence and collapse have occurred were carried out, including at places where walls have cracked, and wells had no water (Figure 3).

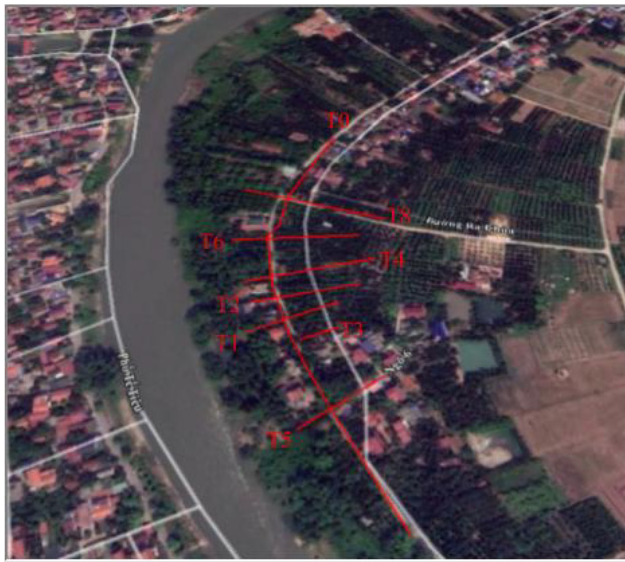
Figure 4: The route diagram measures the depth of polarized excitation and the number.

difference in electrical resistivity of bedrock, karst caves, and unconsolidated sediments is the physical basis for applying the electrical resistivity measurement method. Karst caves often contain water and Quaternary sediments, which are excellent electrical conductors and can be detected by electrical resistance measurement. We designed and carried out geophysical measurement lines where land subsidence and collapse occurred (Figure 4).

In the area where subsidence occurred, we designed resistance survey lines (Figure 4). Geophysical measurement results are linked with wellbore data to explain the cause of land subsidence (Figure 8).

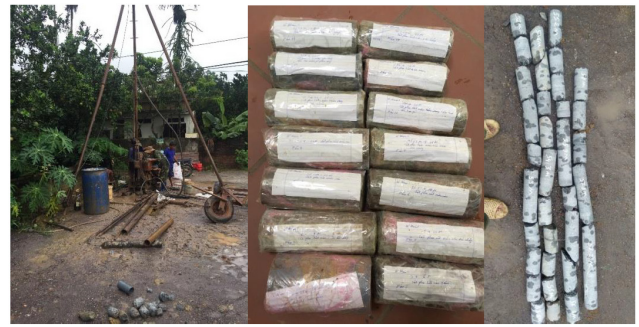
Figure 6: Well-bore geological survey, karst cave identification, and sampling.

Researching well-bore structures is very important work for interpreting, identifying causes, and proposing remedial measures. At locations where land subsidence occurred, we conducted geological survey drilling, took samples for testing and analysis, and performed water pumping experiments (Figure 6).

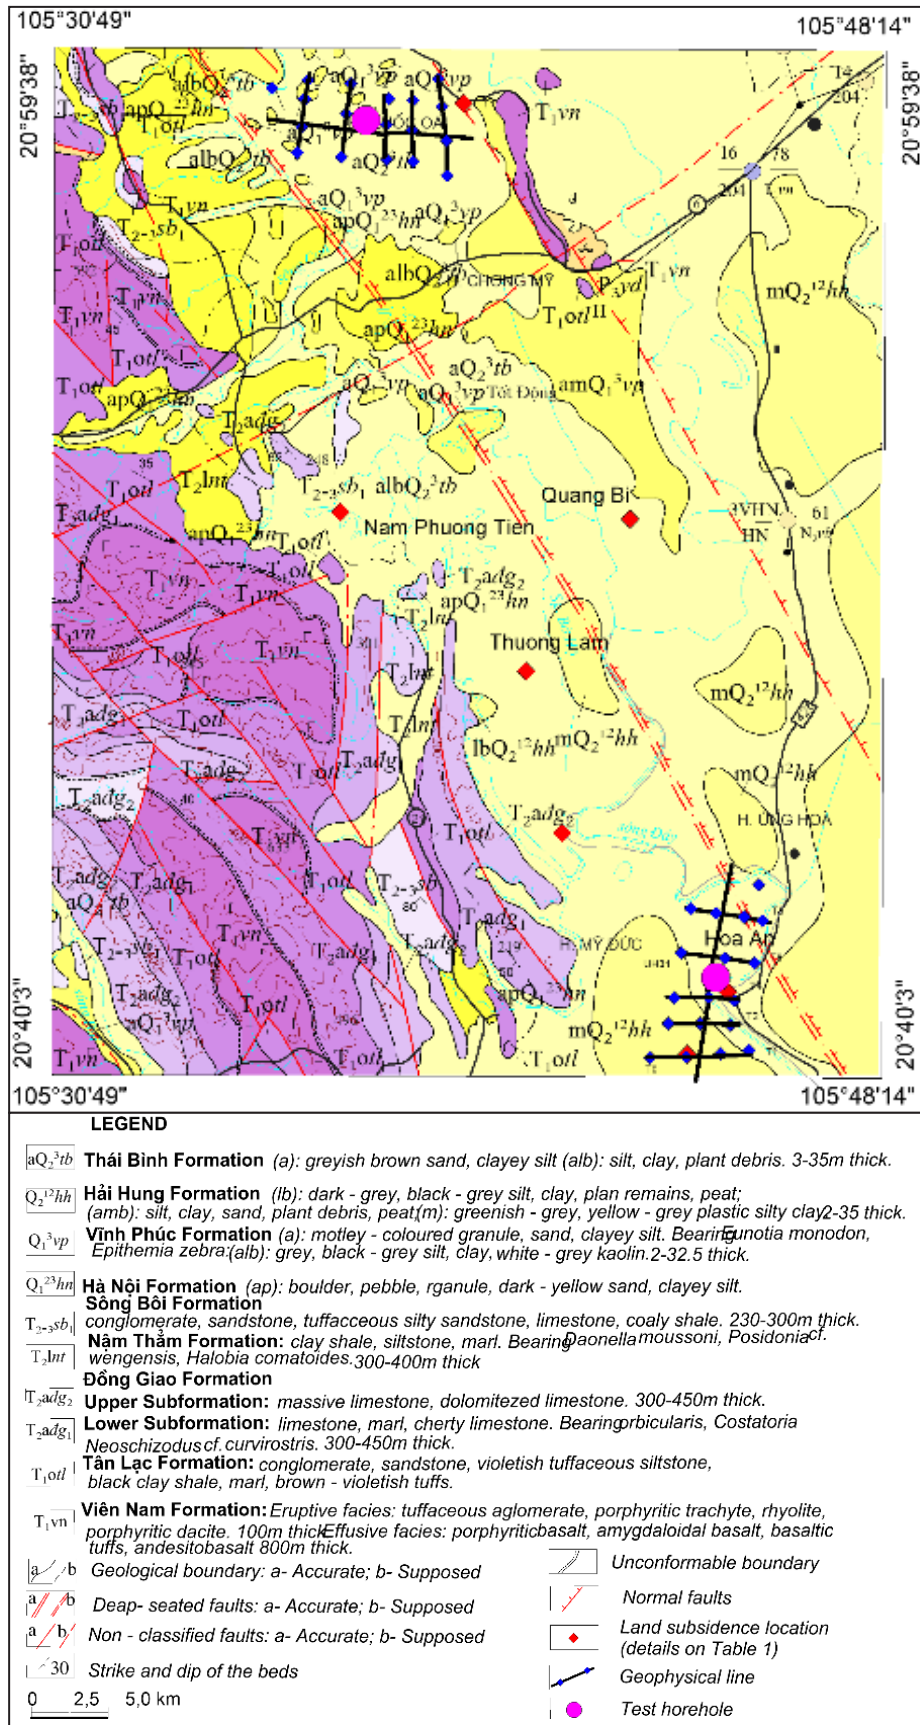
Figure 7: Geological map and location of land subsidence.

The study area has a complex geological structure, with long-term geological activities, from about 300 Ma. The results of the 1:50,000 scale map from the geological research are as the following (Toan *et al.*, 1994) (Figure 7):

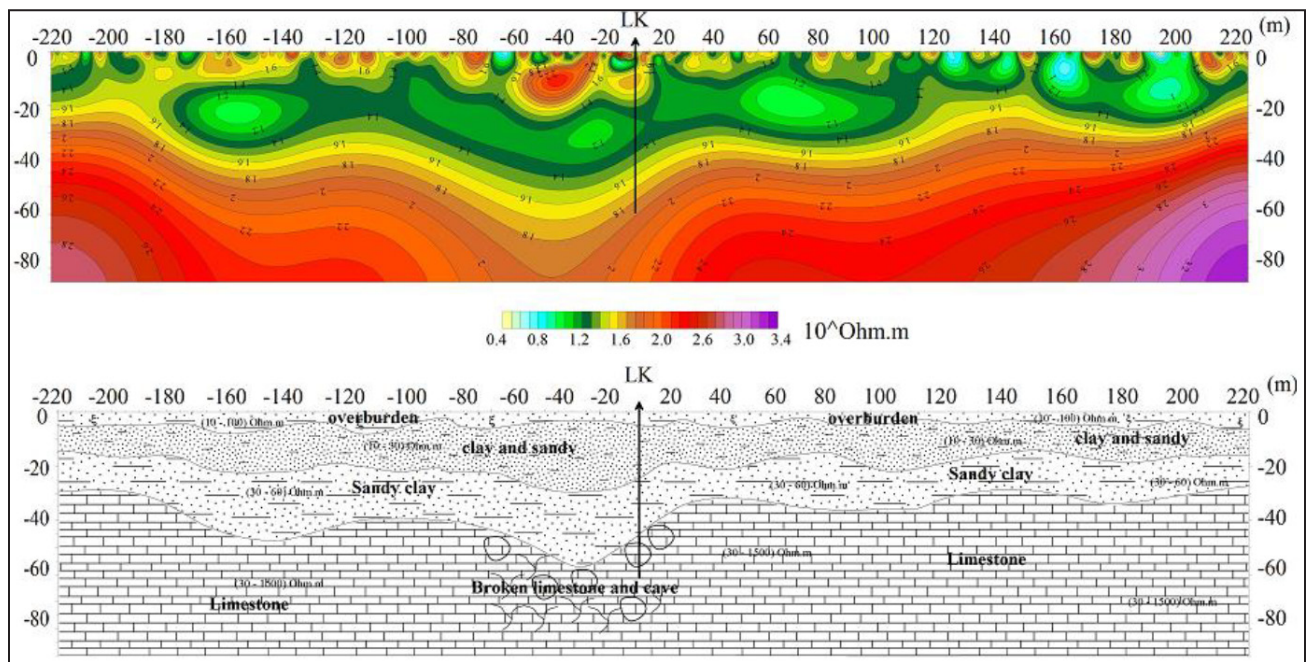
Figure 8: Structural interpretation of places where land subsidence occurred using geophysical and well-bore methods.

During the borehole process, we carefully monitor the soil and rock composition from top to bottom, stratigraphically describe it, take samples, and record field logs carefully. The boreholes are linked to geophysical measurements to interpret the results.

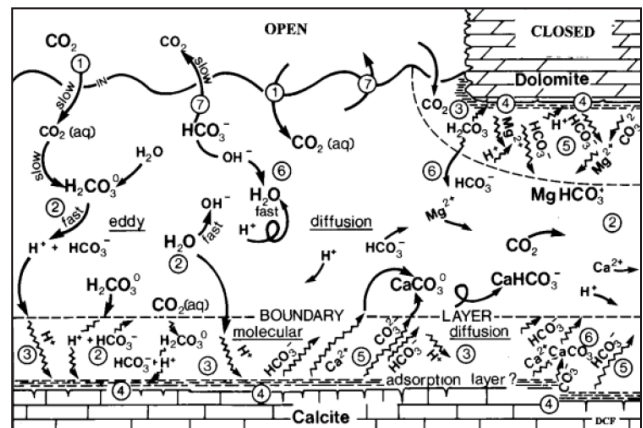
Figure 9: The process of dissolving rocks of karst landform (Derek & Paul, 2007; Petar T. Milanovic, 2018).

Equation (1) is simulated by Derek & Paul (2007) and Petar T. Milanovic (2018) in Figure 9.

The process of dissolving limestone according to reaction (1) has formed karst caves. In the Quaternary period, the Hanoi Delta was formed. Together with river activities, five types of soil structures have been created as in Table 1 (Binh, 2015; Binh *et al.*, 2021).

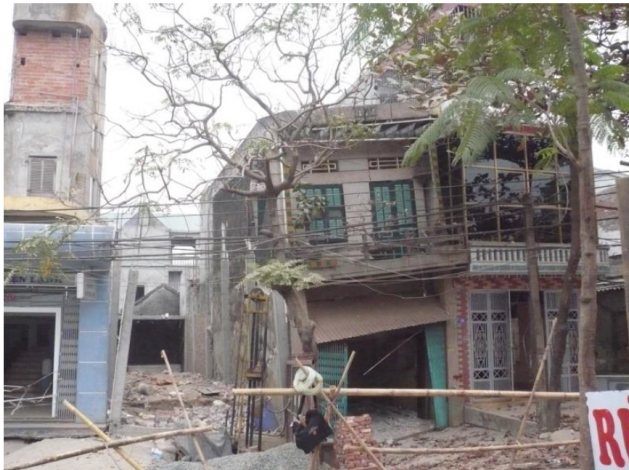
Figure 10: Land subsidence in Quoc Oai in 2008.

In November 2008, when a borehole took water for domestic use at km16, provincial road 419, Quoc Oai town, land subsidence occurred, destroying 2 houses; the danger radius was from 30 m to 40 m (Figure 10). This geohazard incident caused serious damage to property and infrastructure, greatly affecting the lives of some households in the area. It also caused a lot of confusion among people and local authorities (VIGMR, 2008). This land subsidence process is related to foundation structures type 1.
